Task 13 Reliability and Performance of Photovoltaic Systems

# Photovoltaic Failure Fact Sheets (PVFS) 2025

ISBN 978-3-907281-71-0: Task 13 Report: PV Failure Fact Sheets (PVFS) – Review 2025

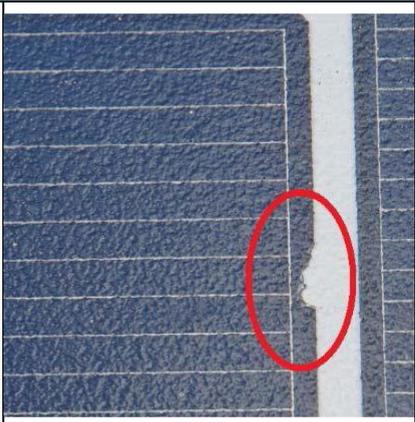
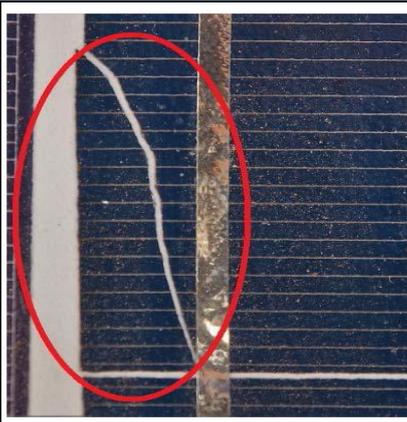
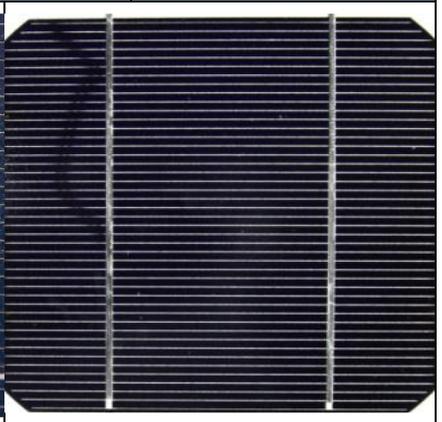
<p>Examples 1-3</p>

<p>Cell chipping. A very small region is missing from the edge of the cell, but does not enter metalized region [Köntges14].</p>	<p>Large crack at cell corner visible by eye - small portion of the cell (&lt;10%) is no longer electrically connected [Köntges14].</p>	<p>Cell crack with snail track. No isolation of any cell part. The propagation could isolate a cell area &gt;10% [Köntges14].</p>
<p>Severity</p>

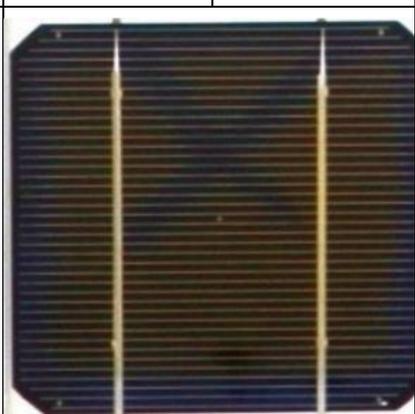
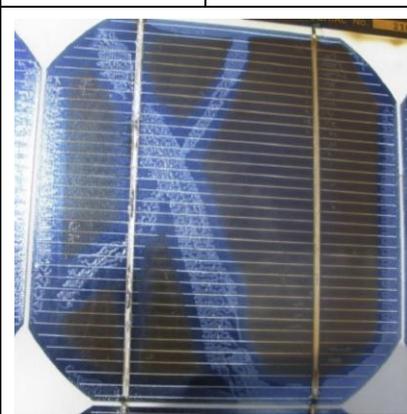
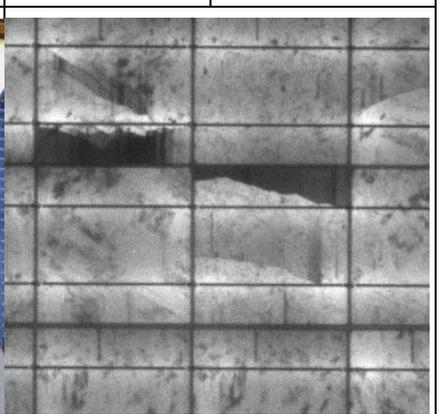
<p>Examples 4-6</p>

<p>Cell cracks visible by the photo-bleaching effect. This may not be mistaken for snail tracks [Köntges14].</p>	<p>Two cell cracks with extensive delamination, EVA browning and photo bleaching [Yang19].</p>	<p>EL image of 2 cell cracks which isolates more than 10% of the cell area [By the courtesy of TUV Rheinland].</p>
<p>Severity</p>

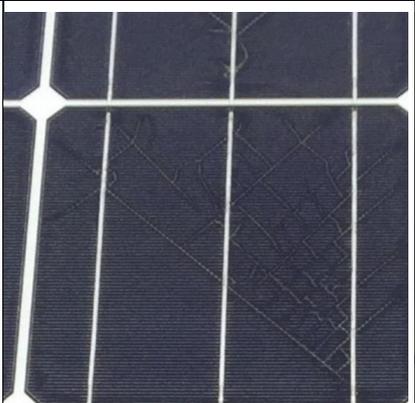
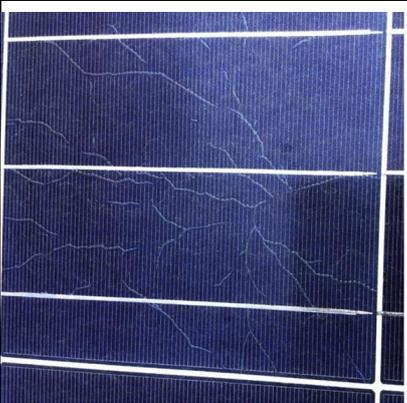
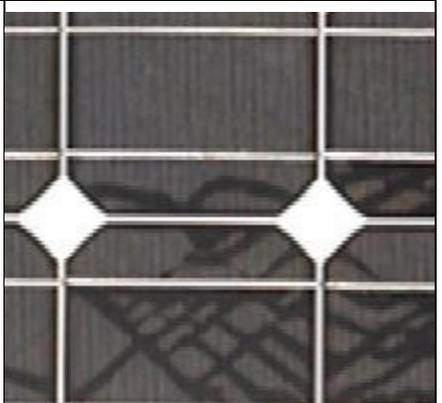
<p>Examples 7-9</p>

<p>Snail track example [Yang19].</p>	<p>Snail track example [Yang19].</p>	<p>EL of cell cracks with snail tracks [Köntges14].</p>

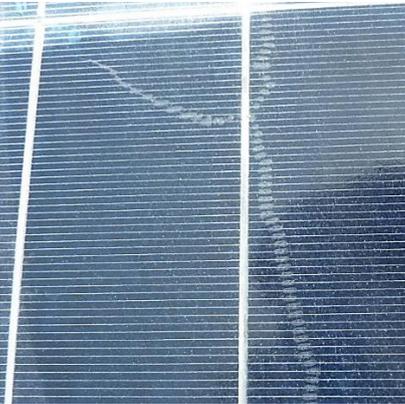
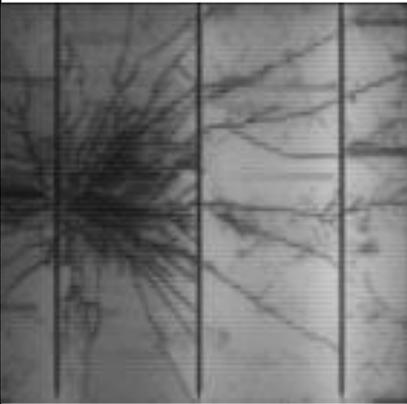
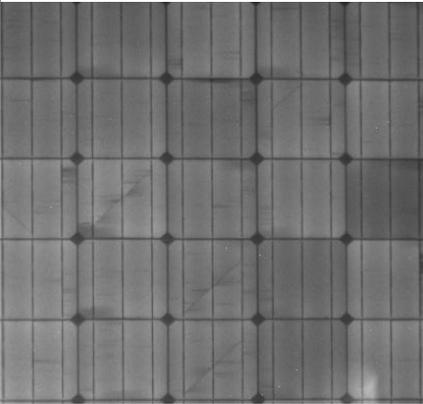
Examples 13-15

Cell crack with EVA delamination [By the courtesy of TUV Rheinland]. (see also PVFS 1-3)	Typical EL picture of a cell crack caused by hail [By the courtesy of TUV Rheinland].	Repetitive crack pattern due to impact of soldering machine [By the courtesy of SUPSI PVLab].
Severity

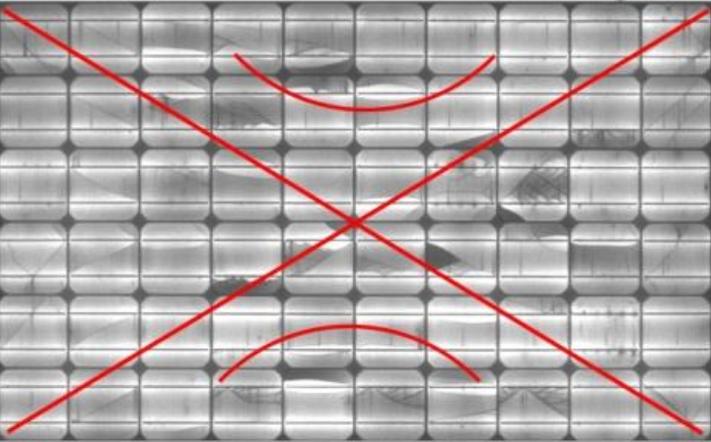
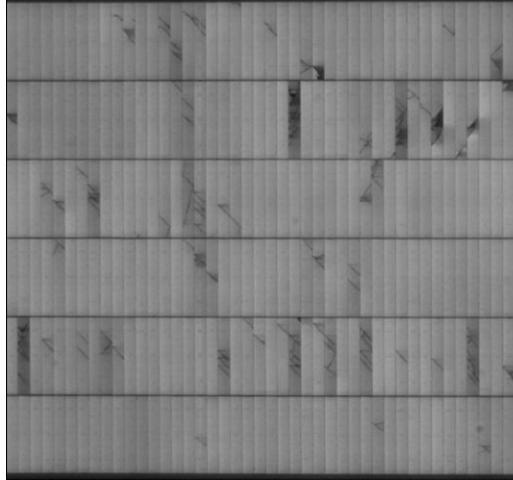
Examples 16-17

Typical EL picture of cell cracks caused by a heavy homogeneous mechanical load (X-crack pattern) also without glass breakage [Köntges14].	Cell cracks in a module with shingled solar cells [By the courtesy of Aerial Inspection].	
Severity

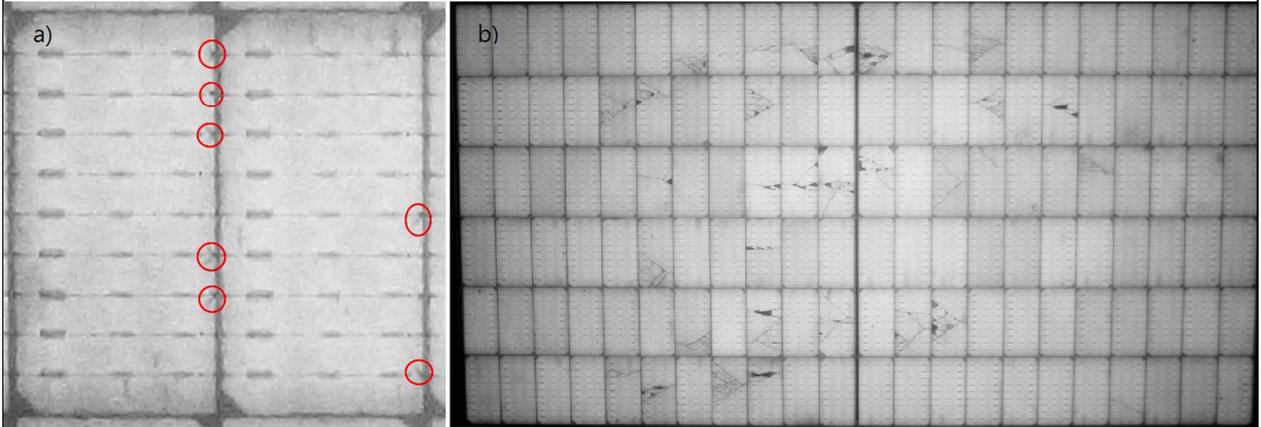
Example 18

Manufacturer related cell cracks (a) in half cut cells and they grew into larger ones after transportation with inactive cell areas below 5% per cell (B) [Köntges24] .

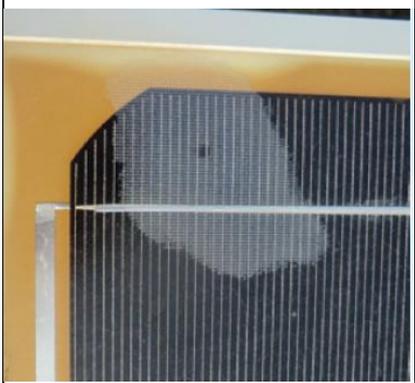
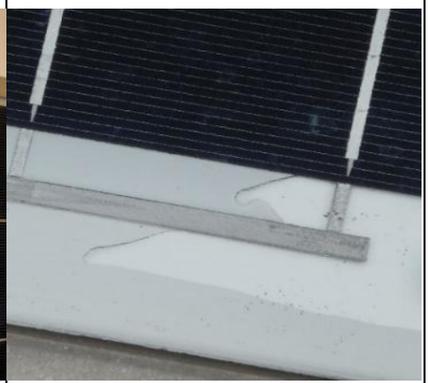
<p>Examples 13-15</p>

<p>Delamination creating a continuous path between electric circuit and the edge [Moser17].</p>	<p>Delamination with corrosion [Köntges17]. (see also FS1-11)</p>	<p>Delamination caused by detachment of backsheet with exposure of encapsulant from the back [By the courtesy of SUPSI PVLab].</p>	
<p>Severity</p>

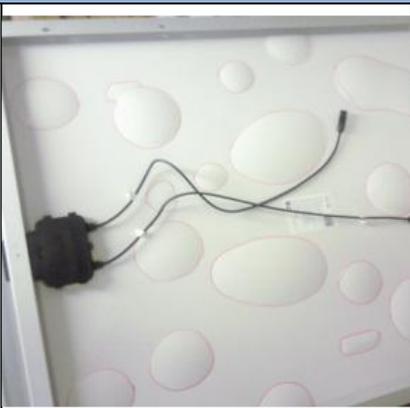
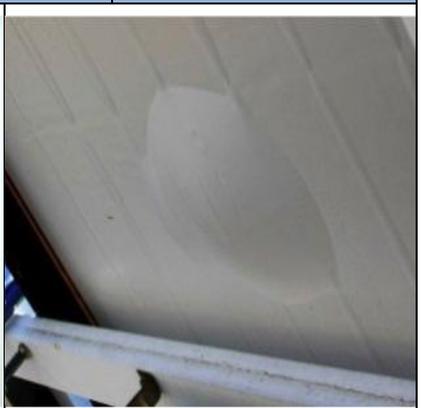
<p>Examples 1-3</p>

<p>Multiple bubbles in the centre and edge of the backsheet [Köntges16].</p>	<p>Blisters because of vapour barrier, such as aluminium foil [Köntges17].</p>	<p>Big central bubble + wavy delamination [Köntges14].</p>			
<p>Severity</p>

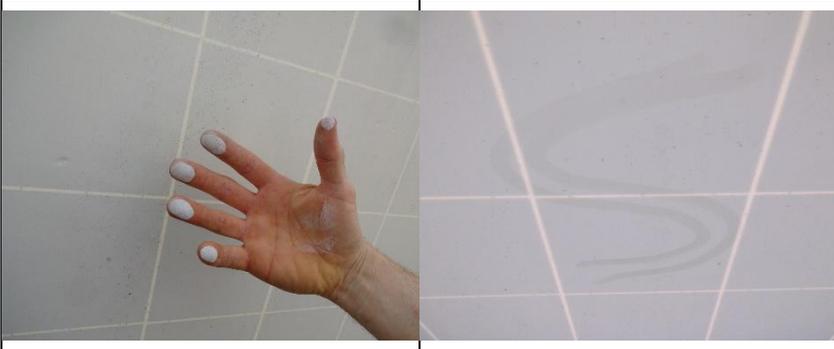
<p>Examples 1-2</p>

<p>Finger with white powder [By the courtesy of TUV Rheinland].</p>	<p>Fingerprint on a module with chalking [By the courtesy of TUV Rheinland].</p>	
<p>Severity</p>

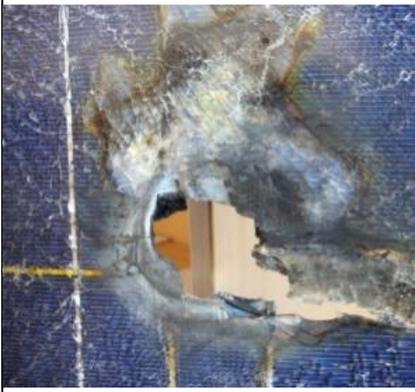
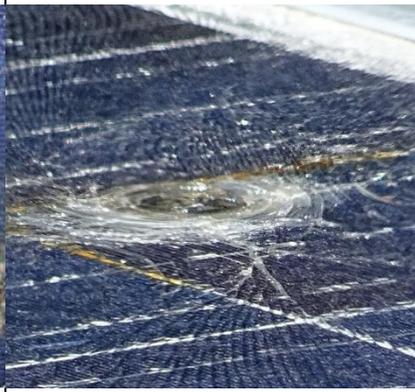
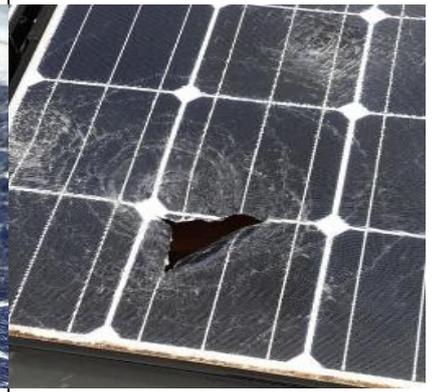
Examples 10-12

Direct lightning stroke [Köntges16].

Impact damage caused by a heavy object [By the courtesy of SUPSI PVLab].

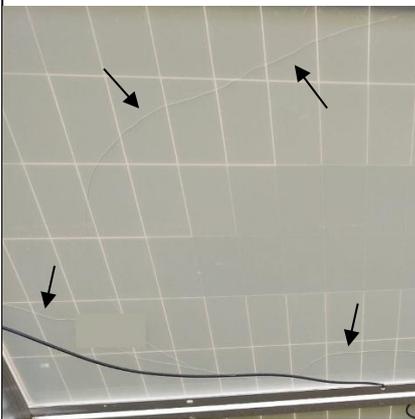
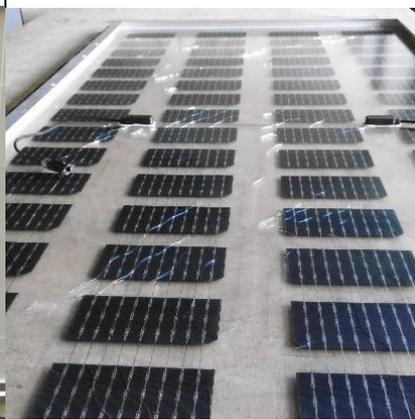
Examples 13-15

Broken thin ( $\leq 2$  mm) rear glass. Long (many dcm) crack lines without splitting the crack with no clear crack start.

Glass breakage on the rear side of a bifacial module caused by insufficient spacing between modules (thermal expansion of module frame is not considered).

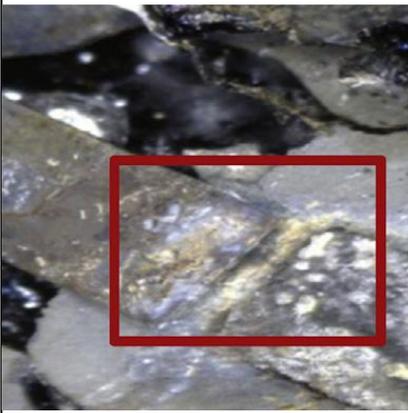
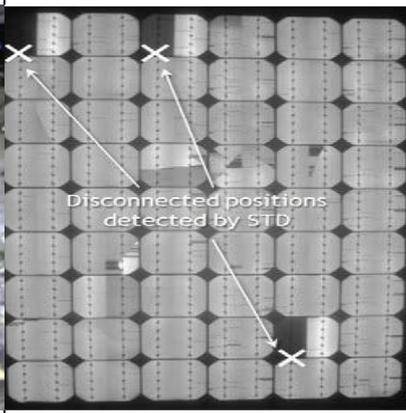
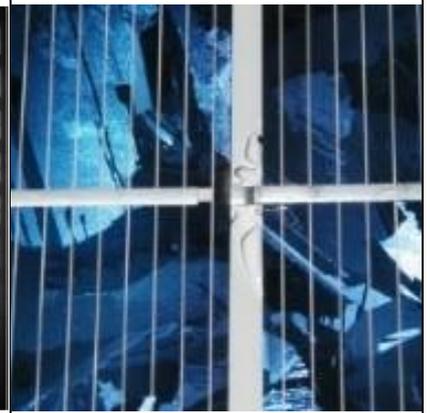
Examples 1-3

Zoom of a broken cell interconnect [Yang19].

EL image of a module with 3 cells with disconnected inter-connect ribbons [Köntges14].

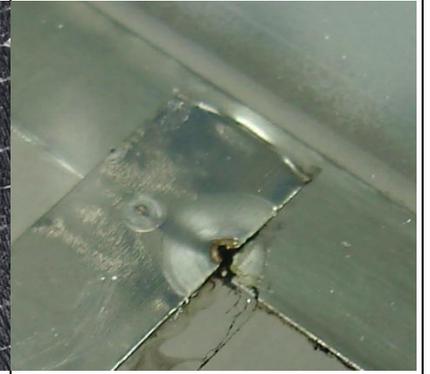
Examples 4-6

Dislocation of interconnection ribbon [Sinclair17].

Poor soldering of string interconnect leading to burn mark and broken glass [Yang19]. (see also PVFS 1-7 and PVFS 1-8)

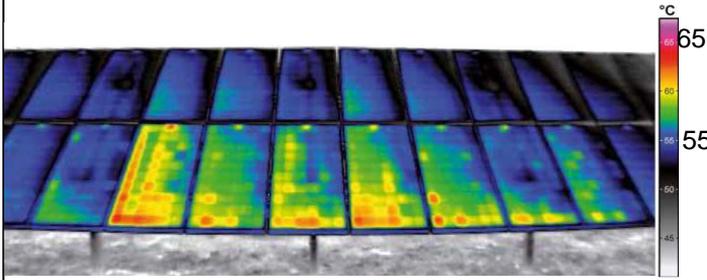
Examples 1-2

Strings with PID-s, detected with IR thermography [Köntges14].

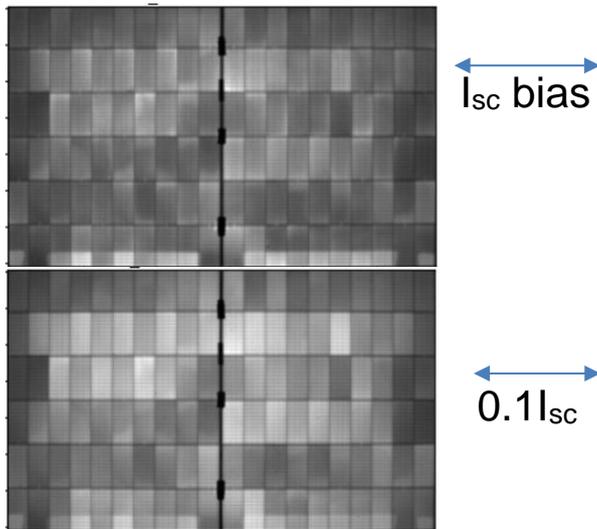
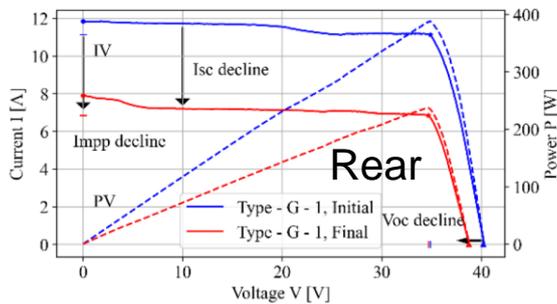
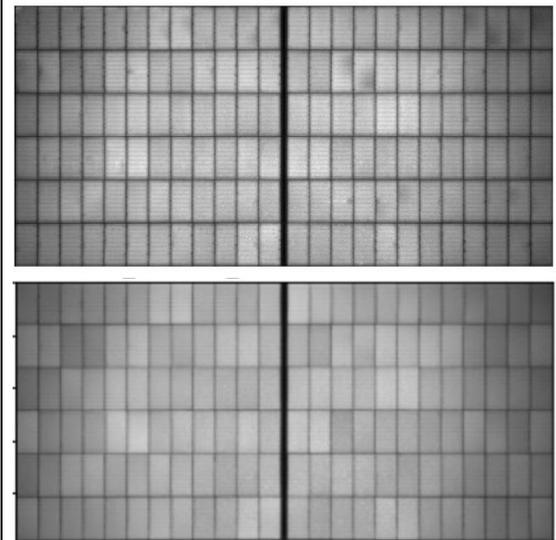
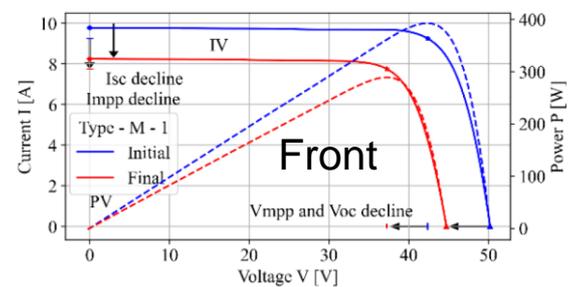
Examples 9-10

PID-p affected p-type PERC bifacial module EL imaged at  $I_{sc}$  and  $0.1 I_{sc}$  shows a decrease in minority carrier lifetime and luminescence. Rear side STC IV shows significant decrease of  $I_{sc}$ , and moderate decrease of  $V_{oc}$ . No noticeable decrease in shunt resistance [Mahmood2024].

PID-p affected n-type TOPCON bifacial module EL imaged at  $I_{sc}$  and  $0.1 I_{sc}$ , shows a uniform and significant decrease ( $\sim 18$  times less) in luminescence relative to a non-degraded module, and no noticeable current dependency of the EL image. Front side STC IV shows a significant decrease in  $I_{sc}$  and  $V_{oc}$  and no noticeable decrease in shunt resistance [Mahmood2024].

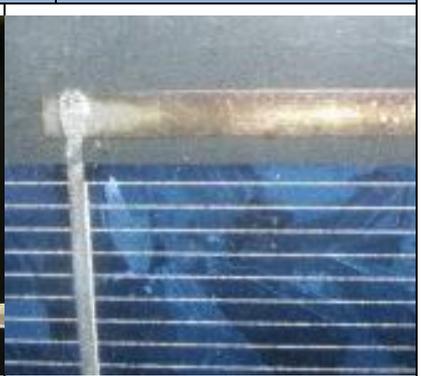
<p>Examples 1-3</p>

<p>Discolouration due to corrosion or to light-sensitive flux residues on the ribbon.</p>	<p>Discolouration due to corrosion on the ribbon [By the courtesy of SUPSI PVLab].</p>	<p>String interconnect corrosion. [Köntges17]</p>			
<p>Severity</p>

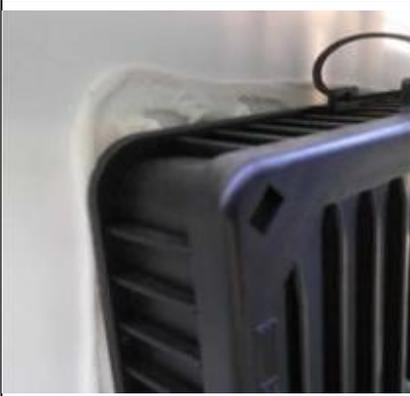
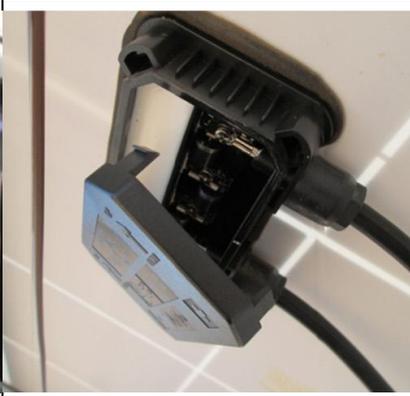
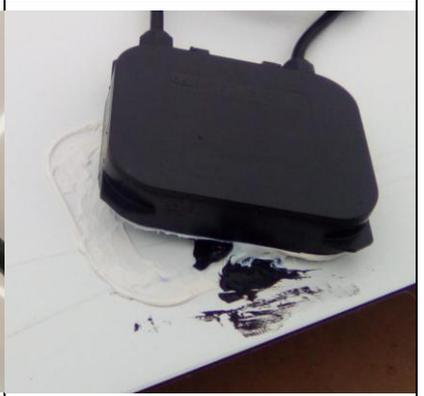
<p>Examples 1-3</p>

<p>Poorly bonded junction box on the backsheet [Köntges14].</p>	<p>Open junction box in the field [Yang19].</p>	<p>Detached junction box from backsheet [By the courtesy of SUPSI PVLab].</p>
<p>Severity</p>

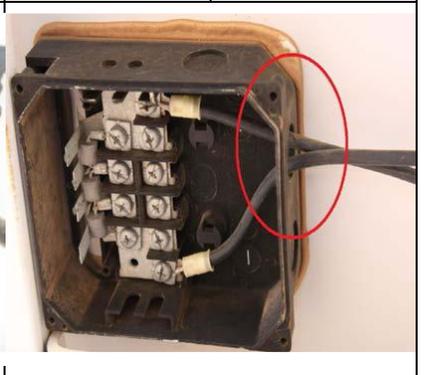
<p>Examples 4-5</p>

<p>Left: Missing junction box lid sealing with corrosion of contacts. Right: Good junction box sealing [India13].</p>		<p>Missing seal or strain relive of module cables, improper cable inlet [Sinclair17].</p>
<p>Severity</p>

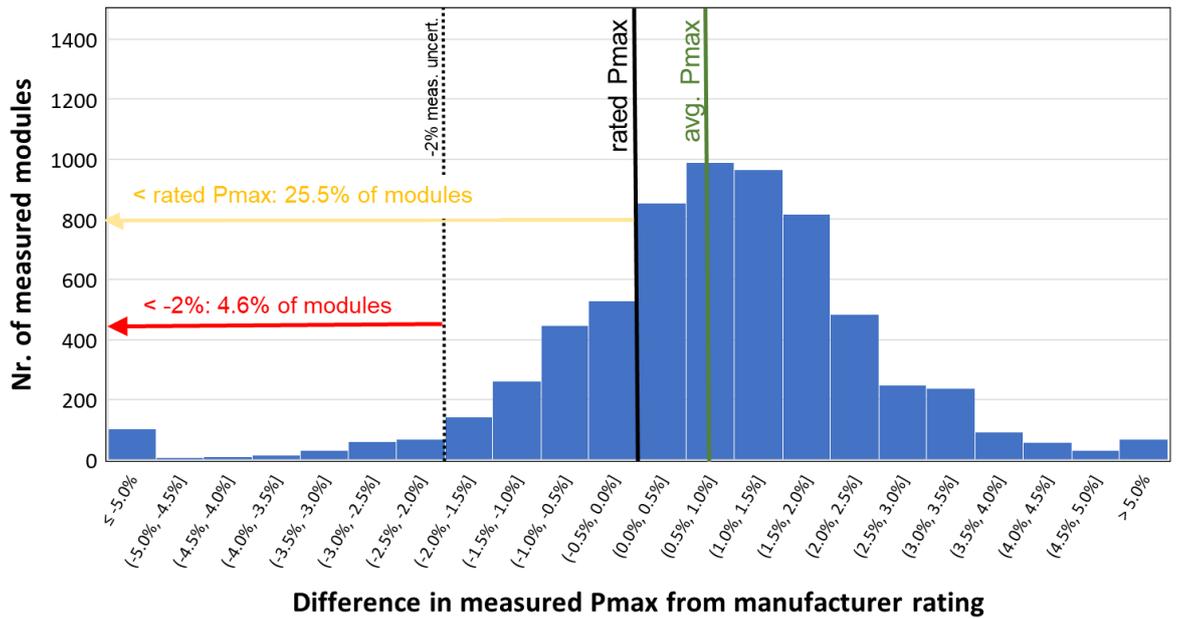
Examples  
2

Statistical analysis done by Eternalsun on around 6500 new modules with 96 different PV module types from 29 different manufacturers. [Herrmann21] Considering the measurement uncertainty of +/-2% a total of 4.6% of the modules are below the gate 1 limit defined by the IEC 61215 standard [IEC 61215-1:2021].

Note: In case of a measurement uncertainty of +/-5% none of the PV modules would fail, but it would be not conform to the IEC 61215 standard prescribing a maximum measurement uncertainty for c-Si modules of +/-3%.

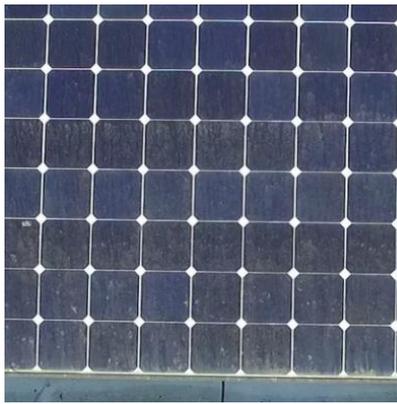
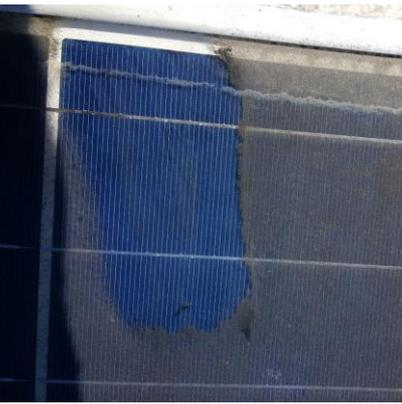
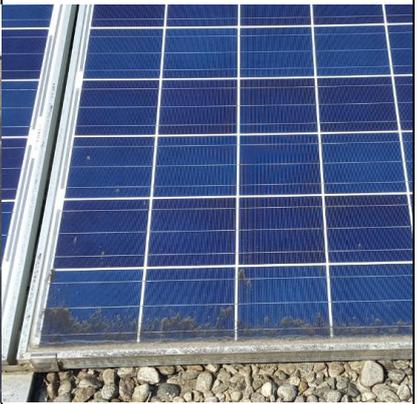
Examples 1-3

Uniform light soiling, which in ideal conditions is self-cleaning when raining [By the courtesy of SUPSI PVLab].

Uniform heavy soiling caused by rail way station [By the courtesy of SUPSI PVLab].

Mitigation	Corrective actions	Preventive actions (recommended)	Preventive actions (optional)
	Cleaning by qualified persons is recommended when the revenue lost because of the missed energy production is higher than the cleaning cost. A best time to clean should be defined.	Preliminary site inspections for the assessment of the soiling risk. Cost estimation for the implementation of mitigation measures. Regular visual inspections to control the soiling level.	Estimation or measurement of soiling losses prior to installation. Installation of soiling sensors to determine the most profitable time to clean.

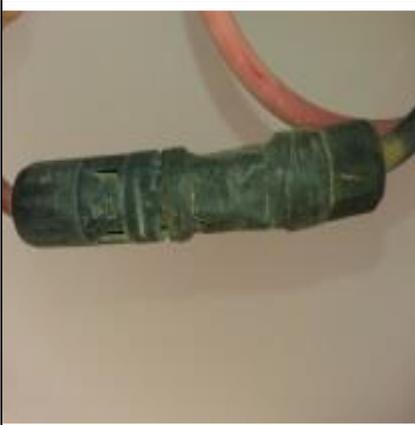
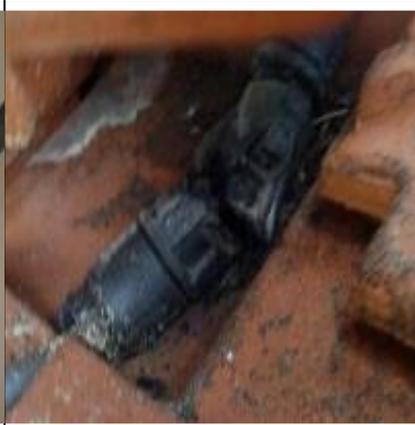
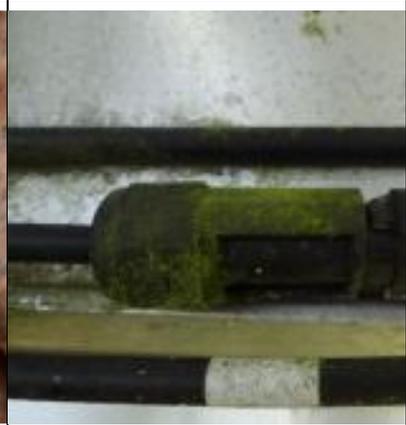
<p>Examples 1-3</p>

<p>Weathered connector [Köntges17].</p>	<p>Cracked connector [Köntges17].</p>	<p>Corroded connector [Köntges17].</p>			
<p>Severity</p>

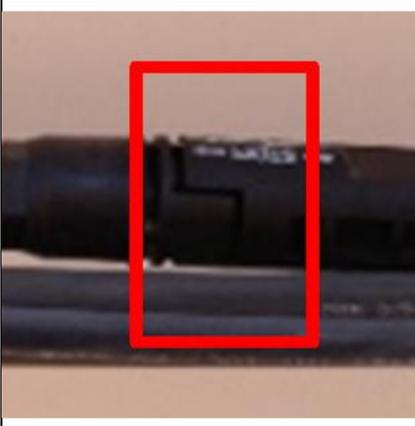
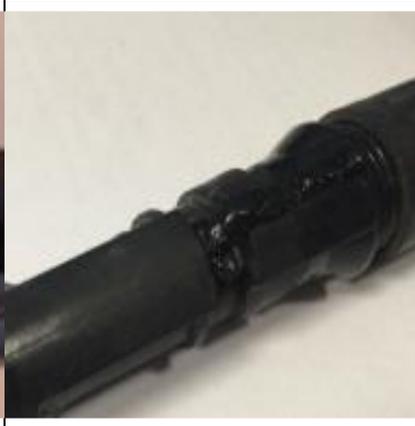
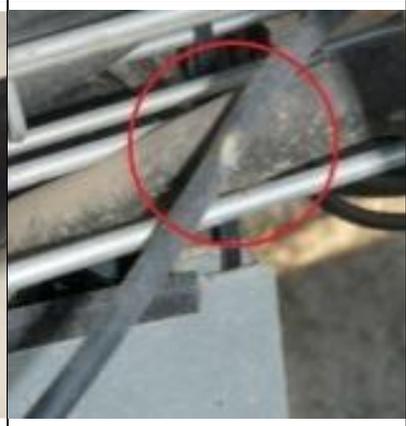
<p>Examples 4-6</p>

<p>Not fully inserted or interlocked connector [Yang19].</p>	<p>Melted connector [Köntges17].</p>	<p>Cracked/disintegrated cable insulation [Köntges17].</p>			
<p>Severity</p>

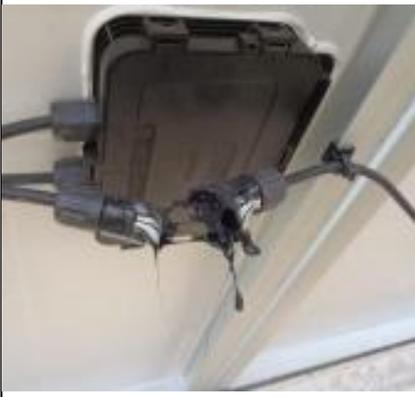
Burned connector [Köntges17].

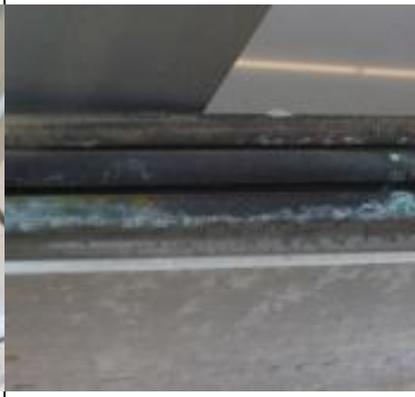
Corroded Cable [Köntges17].

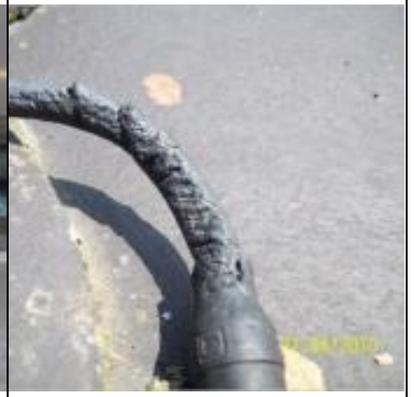
Animal bite on cable [Köntges17].

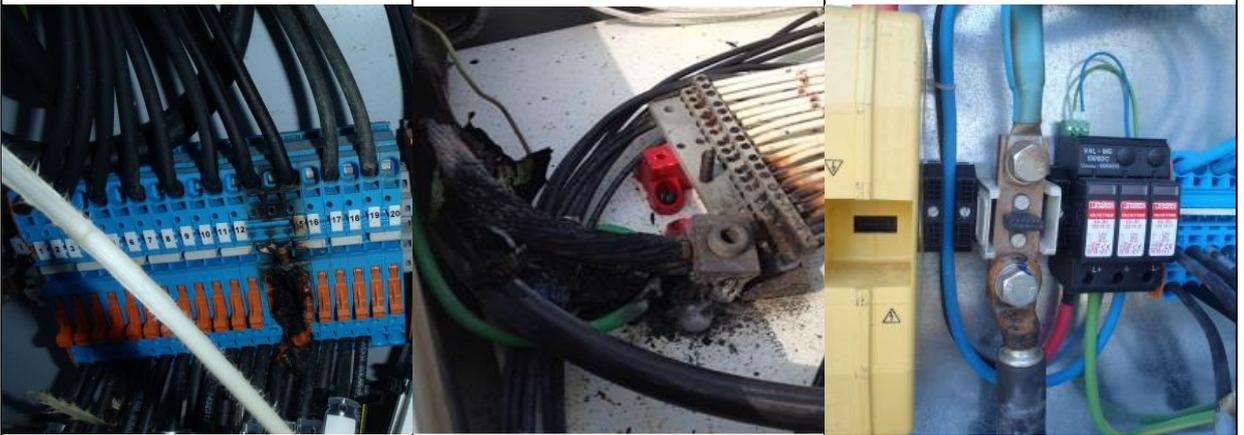
Examples 1-3

Burned terminal block of the combiner box [TUV Rheinland].

Improper wire torquing causes a fire [Köntges16].

Safety:		Performance:	
Mitigation	Corrective actions	Preventive actions (recommended)		Preventive actions (optional)
	Replace the components with defect or abnormal temperature.	Use IRT to check the components and connection to find poor connection or defect components.

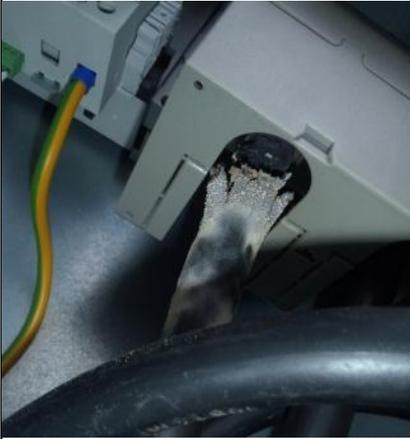
Examples 4

Connecting terminals show signs of burning, have melted or charred [TUV Rheinland].

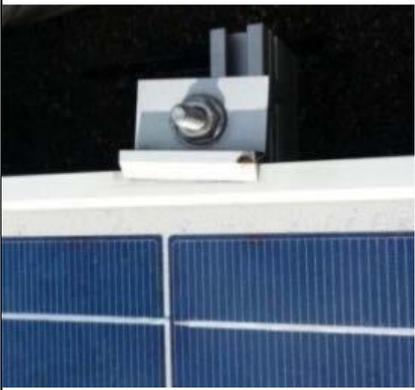
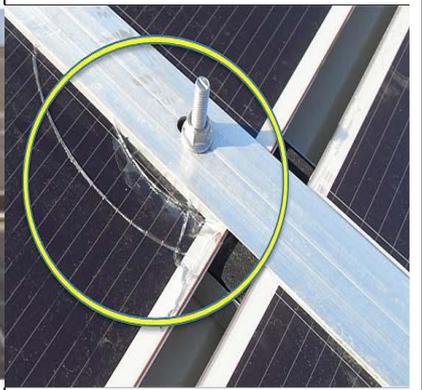
Examples 1-3

Improper installation of clamp [By courtesy of SUPSI PVLab].

Wrong combination of clamps and modules [Moser17].

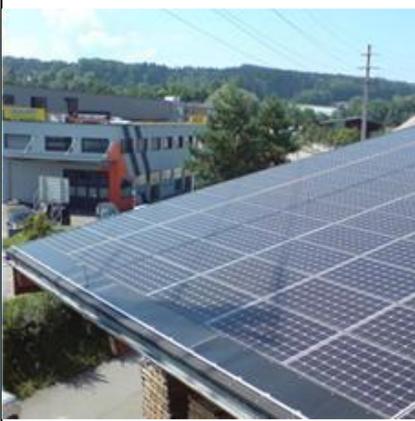
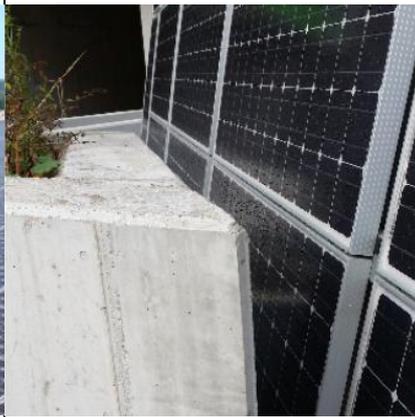
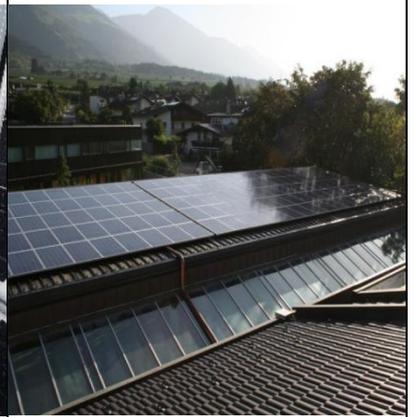
Examples 1-3

Shading by pole-and-wire (poor design: too close to nearby shading objects) [Jahn18].

Shading due to bad planning or coverage by afterwards build construction element. [Moser17].

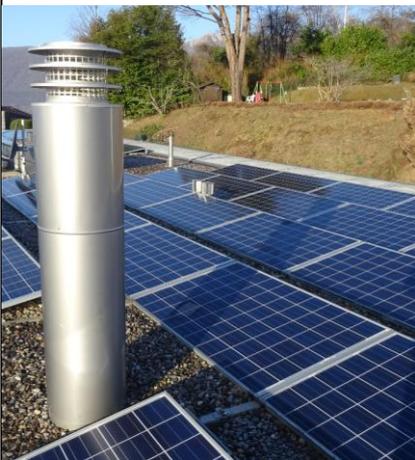
Examples 7

Continuous shading caused by chimney [By courtesy of SUPSI PVLab].
