PID – POTENTIAL INDUCED DEGRADATION

TESTING – ROOT CAUSE ANALYSIS – CHARACTERIZATION

Fraunhofer Center for Silicon Photovoltaics CSP

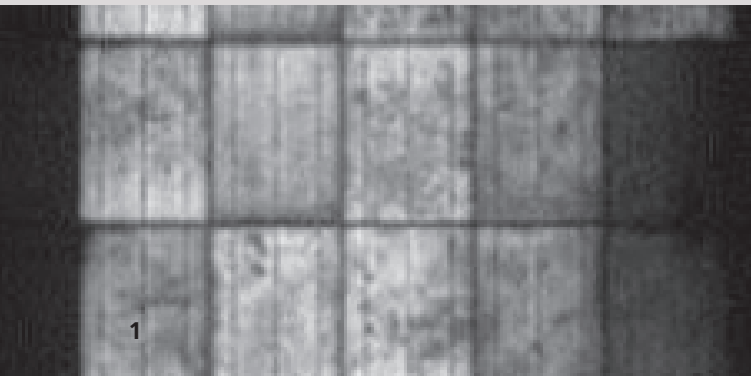
- 1 *Electroluminescence image of a solar module suffering from PID-s.*
- 2 *PIDcon.*

In conventional photovoltaic (PV) systems under working conditions, a voltage difference of a few hundred volts between the framing and the solar cells of a module can occur. If the modules/cells are not PID resistant, this can lead to the so called Potential Induced Degradation (PID) effect resulting in yield losses of 20 percent or more.

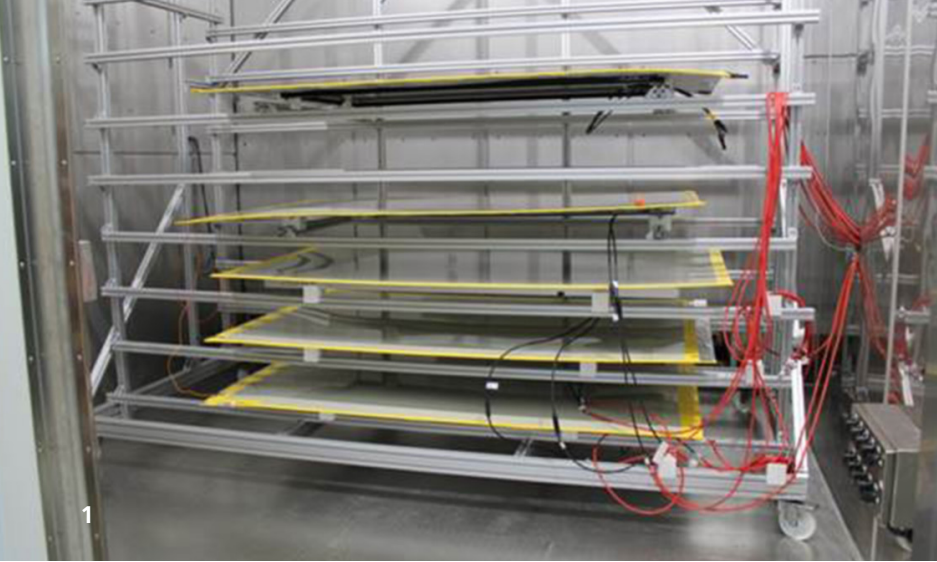
- 1 *Experimental setup of the voltage stress test in the climate chamber.*
- 2 *Transmission electron microscope characterization of a PID shunt in cross section.*

At Fraunhofer CSP accelerated high voltage tests are performed on standard PV module scale as well as on mini-module scale in climate chambers and also for non-encapsulated solar cells.

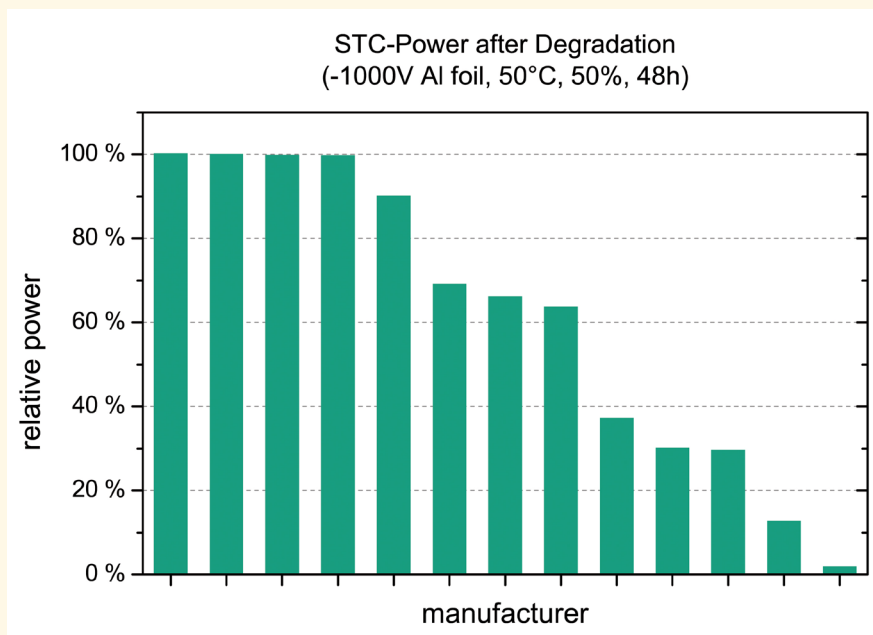
3 *Relative module power at the modules' operating point after the test.*
