CLEANING RESISTANCE OF GLASS COATINGS

Test Report V403/2018

Project Number: 431168

Project Name: CSP_fglasBau1

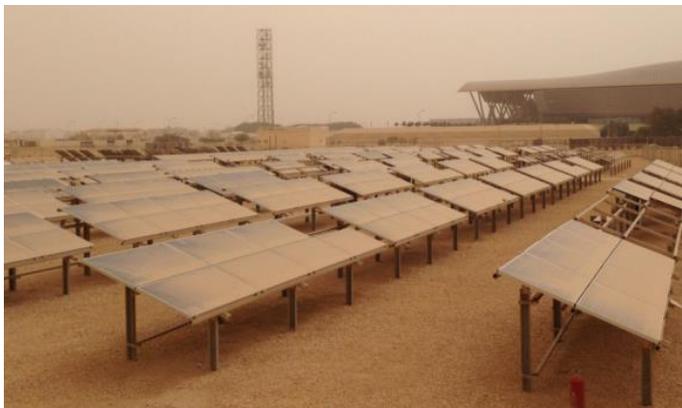
Figure 1: Soiled PV modules, image was taken at the STF of QEERI after a dust storm in Doha, Qatar.

Regular cleaning of PV modules can damage glass surfaces and glass coatings. It becomes especially relevant in desert areas with high cleaning frequency due to increased soiling of the glass surfaces.
