Task 13 Reliability and Performance of Photovoltaic Systems

Degradation and Failure Modes in New Photovol- taic Cell and Module Technologies 2025

ISBN 978-3-907281-71-0: Task 13 Report: Degradation modes and Failure in New PV Cell and Module Technology

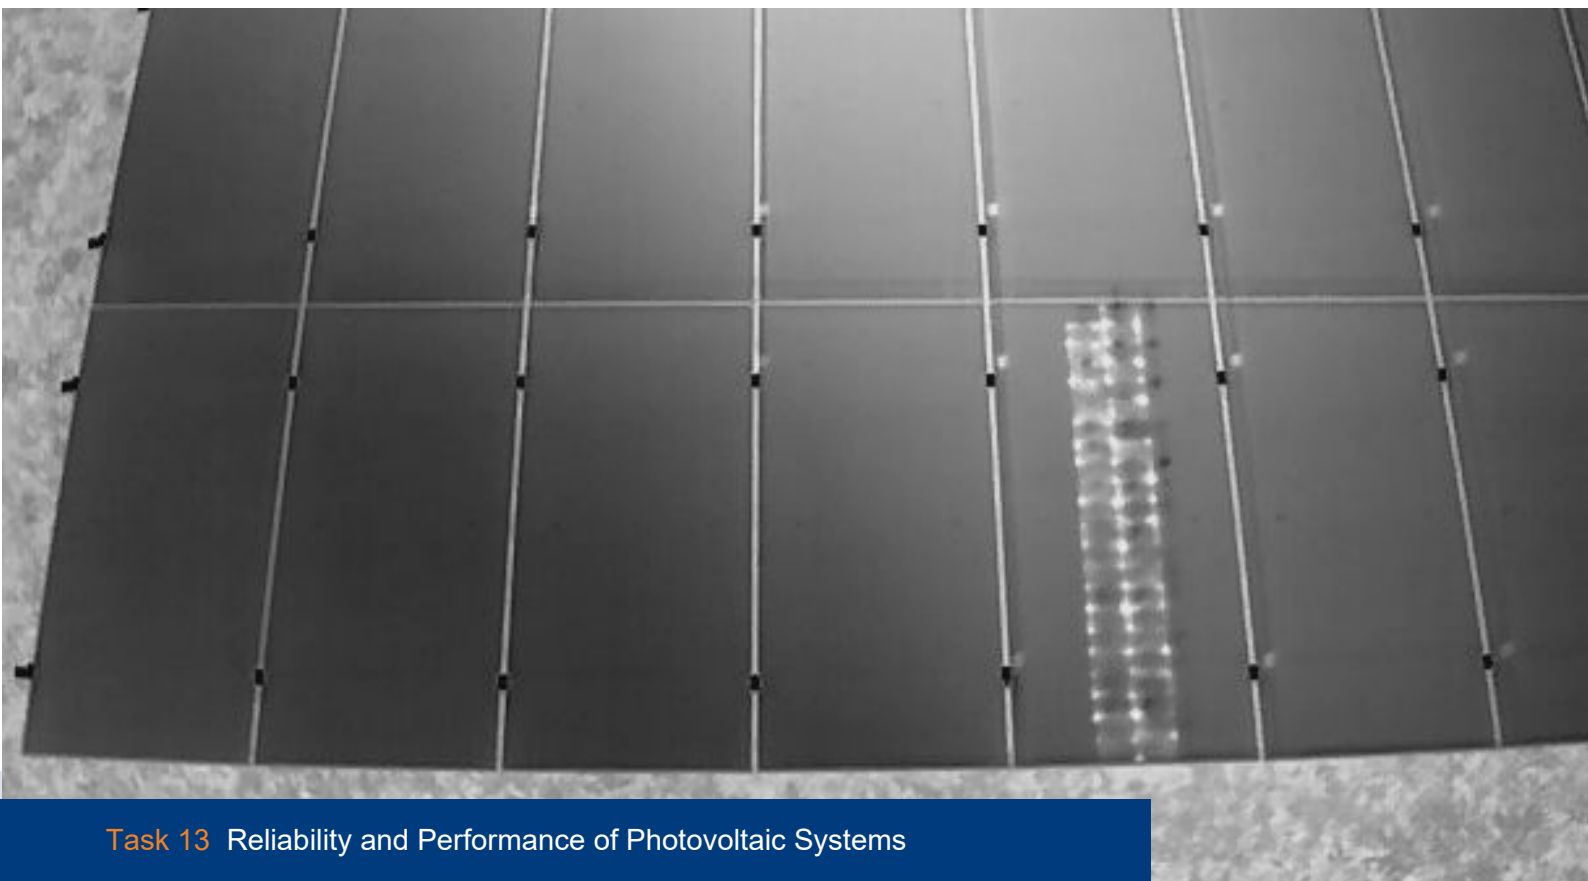
COVER PICTURE

Infrared image of an energised module string at night. One module has a not connected bypass diode. Thanks to photovoltaikbuero Ternus & Diehl GbR for the permission to use the image.

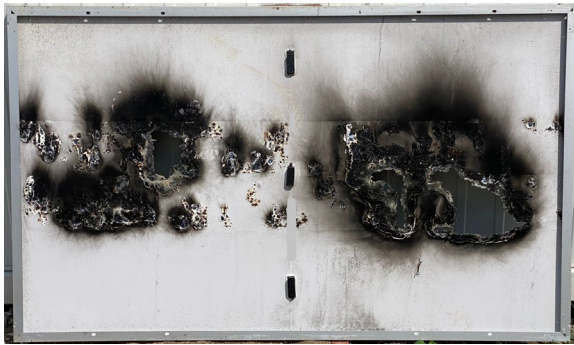
Figure 15: Rear side of TOPCon PV module with failure mode A being shaded by natural obstacles. Module has already been dismantled from the mounting rack.

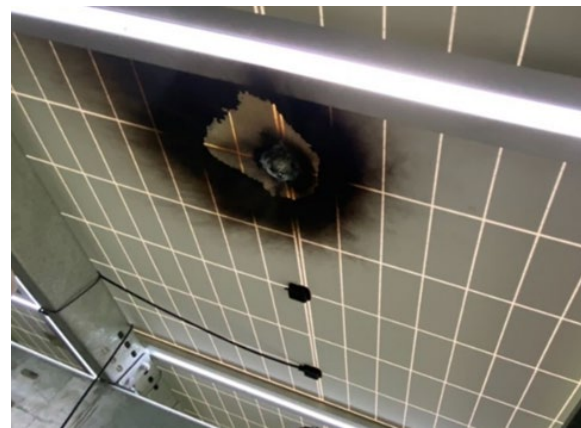
Figure 18: Module with burnt junction box resulting from unstable connection in the junction box.

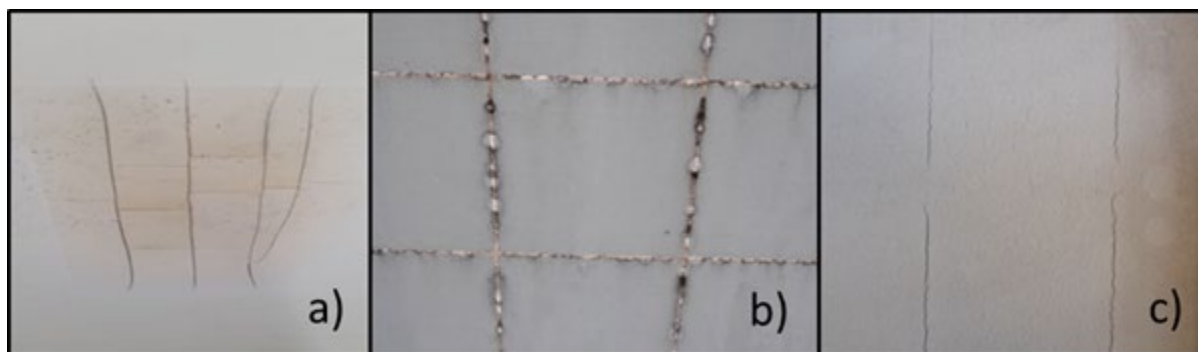
Figure 19: Backsheet crack types. a) cracked backsheet beneath a hot cell/temperature induced crack. b) squared cracks beneath cell interspaces; thermo-mechanical induced crack combined with photo-oxidative degradation. c) longitudinal cracks located beneath busbars; thermo-mechanical stress induced crack [69].

Various types of backsheet cracking can be distinguished [69], [77], [78] and are described in sections 2.5.1.- 2.5.3.

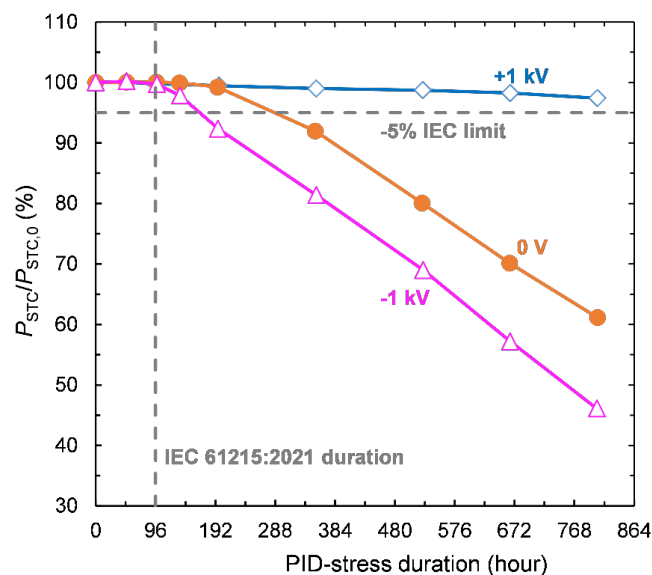
Figure 26: Normalised STC power to initial power of the front-side of SHJ 1-cell glass/glass laminates with EVA, after 800 h of PID testing at 85°C/85% RH for the bias conditions -1 kV, 0 V, and +1 kV. Figure is redrawn from Arruti et al. [134].

Another degradation mode related only to SHJ is studied by Arruti et al. [134]. Arruti et al. have shown that bifacial rear-emitter SHJ solar cells encapsulated in EVA in glass/glass laminates degraded in damp heat (DH) tests. However, DH tests with negative bias applied show a slightly accelerated degradation compared to no voltage applied, see Figure 26. The degradation of the cell under negative bias is shown in the EL images in Figure 27. Modules in positive bias voltage or positive bias voltage with periods of illumination [22] consistently exhibit no degradation during the DH test. The prerequisite for degradation is explained by molecular NaOH from the glass either diffusing through the EVA, which has absorbed moisture, or by Na^+ ions drifting due to the electric field when a negative bias is applied to the cell circuit. Furthermore, with positive bias applied to the cell circuit, apparently Na^+ ions are driven away from the cell and therefore no degradation is observed. In the study by Arruti et al., the sensitivity to migrating Na^+ seemed to be greater on cell fronts than on the rear side [134].

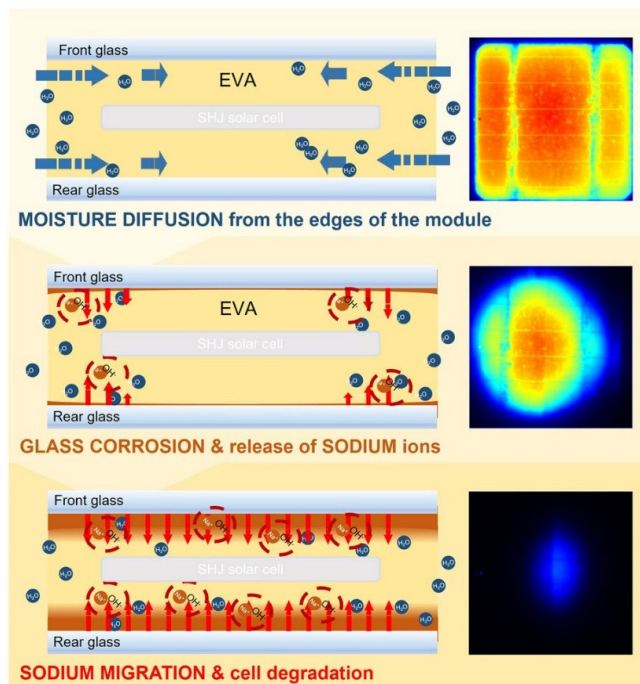
Figure 28: Left: physical model explaining the sensitivity of SHJ to water. The observed degradation mechanism is specific to the SHJ technology [135]. Right: Photoluminescence image of one SHJ cell glass/glass laminate taken at 0 h, 500 h and 1000 h of DH testing.

The mechanisms of moisture damage are multifaceted, and have recently been explained by a corrosion mechanism, see Figure 28 [135]. The adoption of encapsulants with a relatively high water-uptake, such as EVA, favours a corrosion reaction of the glass cover(s) releasing Na^+ ions that, in combination with water, form molecular NaOH . Na^+ ions can diffuse through the grain boundaries of the indium tin oxide (ITO), reaching either the front or rear hydrogenated amorphous silicon (a-Si:H)/c-Si interface creating recombination centres for charge carriers, see Figure 29.
