Task 13 Reliability and Performance of Photovoltaic Systems

# Photovoltaic Failure Fact Sheets (PVFS) 2025

ISBN 978-3-907281-71-0: Task 13 Report: PV Failure Fact Sheets (PVFS) – Review 2025

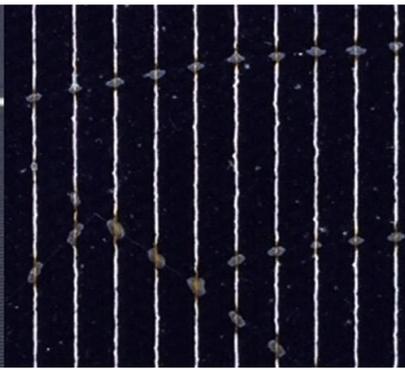
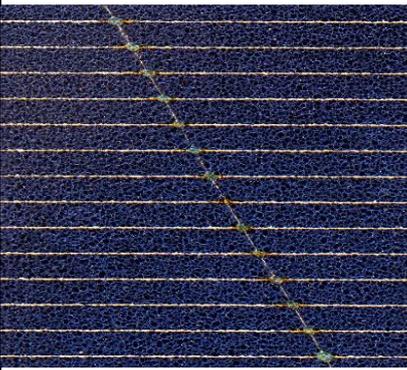
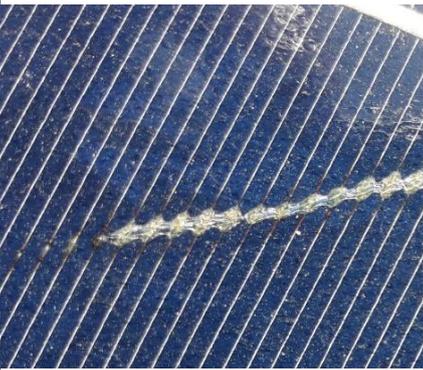
EXAMPLES (page2)		PVFS 1-1vs.02	
Examples 10-12

Zoom of snail track with delamination [Yang19].	Zoom of snail track with browned fingers [Sinclair17].	Zoom of snail track with delamination [By the courtesy of SUPSI PVLab].
Severity

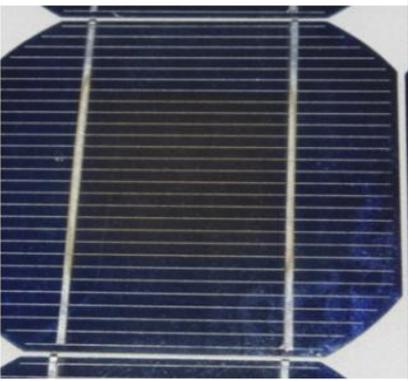
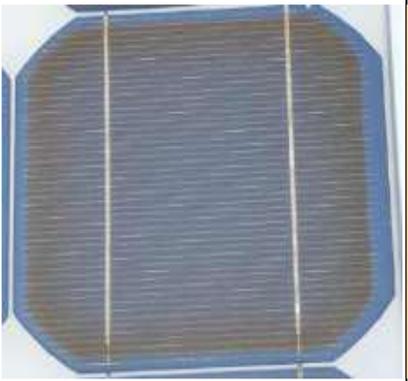
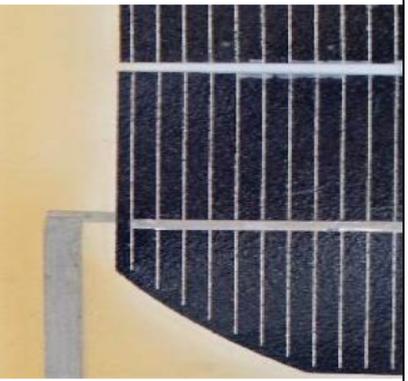
EXAMPLES (page1)		PVFS 1-2vs.02	
Examples 1-3

Slightly browned EVA in the centre of the cell with photobleaching at the edges [Köntges14].	Slightly browned EVA in the centre of the cell with photobleaching at the edges [India18].	Yellowed backsheet from the inside [Sinclair17].
Severity

Mitigation	Corrective actions	Preventive actions (recommended)	Preventive actions (optional)		
	<p><b>Modules with a direct safety risk or a severity of 5 should be replaced.</b> Regular inspections should be done to monitor the status of the not replaced modules.</p>	<p>Check validity of IEC 61215 certification and BOM.</p>	<p>Regular system inspections</p> <p>For areas with harsh climate, request modules pass higher test standards, like double or triple IEC 61215 test condition.</p>

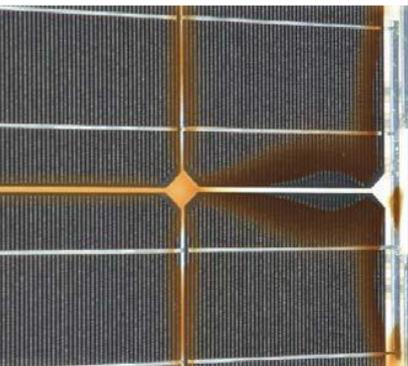
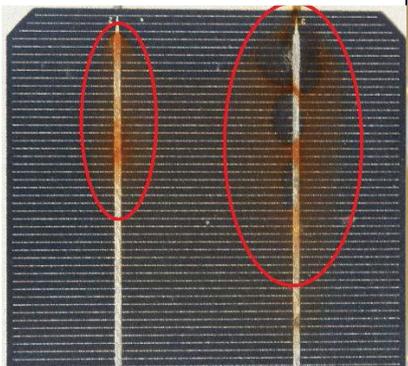
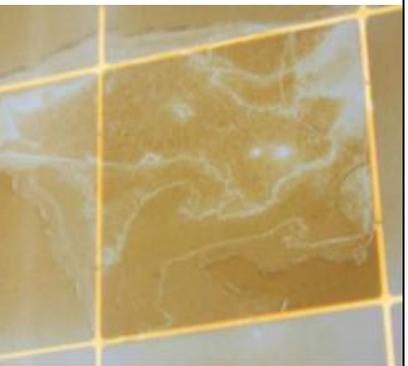
Examples 4-6

Dark discoloration at cell edges, between cells and over gridlines and busbars [Sinclair17].	Dark discoloration over metalization [Sinclair17].	Backsheet air side yellowing [Sinclair17].
Severity

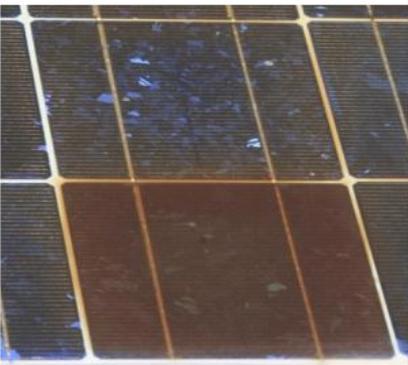
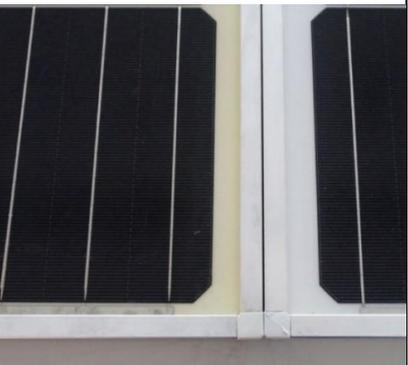
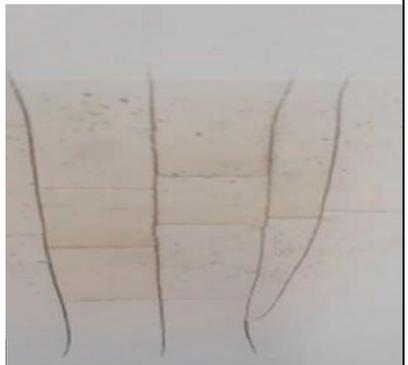
Examples 7-9

Single cell browned much faster than the others due to local heating [Köntges14].	Yellowed backsheet from the inside [By the courtesy of PCLL].	Yellowing of the backsheet in combination with cracked backsheets caused by hot cell [Eder19].
Severity

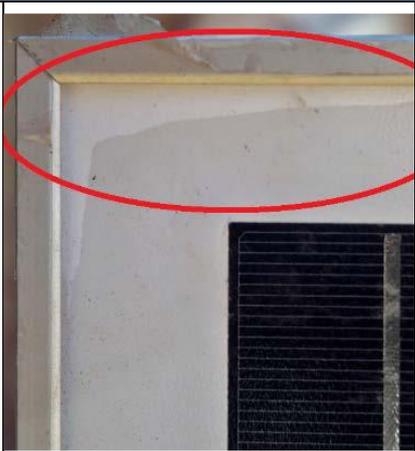
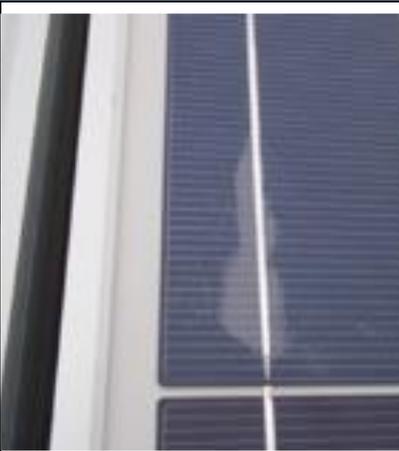
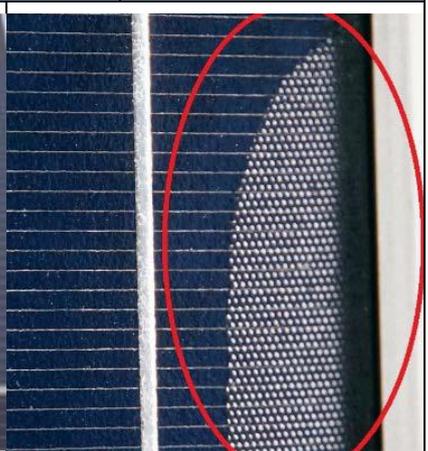
<p>Examples 10-12</p>

<p>Encapsulant delamination at borders [Sinclair17].</p>	<p>Encapsulant delamination along a bus-bar in a cell close to the module edge [Moser17].</p>	<p>Encapsulant delamination of from glass (spotted due to glass texture) at the edge of the cell [Sinclair17].</p>	
<p>Severity</p>

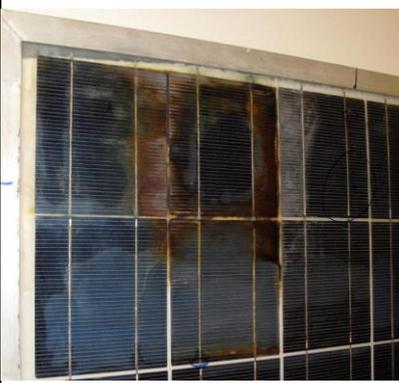
<p>Examples 13-15</p>

<p>Delamination creating a continuous path between electric circuit and the edge [Moser17].</p>	<p>Delamination with corrosion [Köntges17]. (see also FS1-11)</p>	<p>Delamination caused by detachment of backsheet with exposure of encapsulant from the back [By the courtesy of SUPSI PVLab].</p>	
<p>Severity</p>

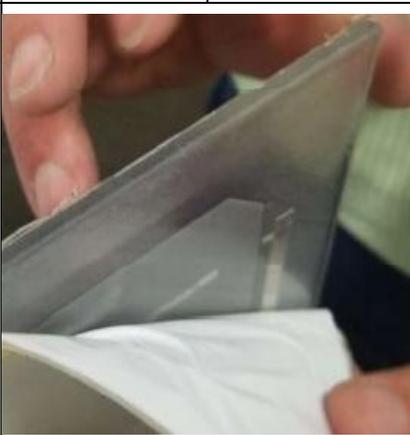
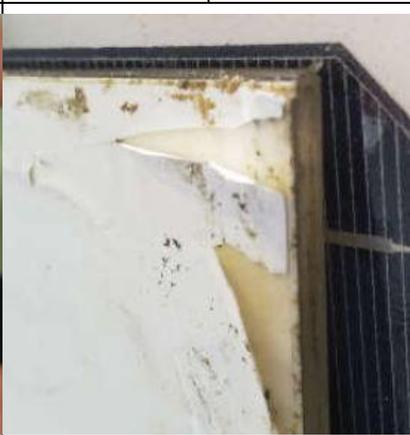
<p>Examples 4-5</p>

<p>Backsheet delamination with direct exposure of encapsulant [By the courtesy of SUPSI PVLab].</p>	<p>Delamination of top layer without exposure of encapsulant [By the courtesy of SUPSI PVLab].</p>				
<p>Severity</p>

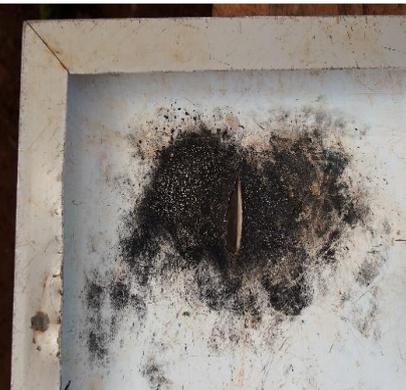
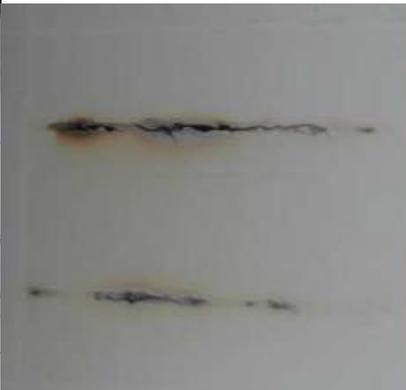
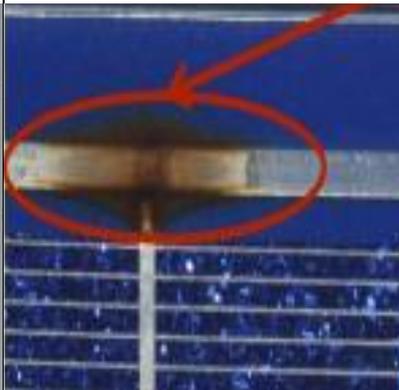
<p>Examples 1-3</p>

<p>Burn mark at the backsheet with cracked backsheet [Sinclair17].</p>	<p>Burn marks at the backsheet due to heating along a busbar [Köntges14].</p>	<p>Burn mark associated with overheating along the metallic interconnection (without back-sheet damage) [Köntges14].</p>
<p>Severity</p>

Performance:
Mitigation	Corrective actions	Preventive actions (recommended)	Preventive actions (optional)
	<b>Modules with a direct safety risk or a severity of 5 should be replaced.</b> Regular inspections should be done to monitor the status of the not replaced modules.	Visual inspection before installation, commissioning of system with IRT.	Regular system inspections.

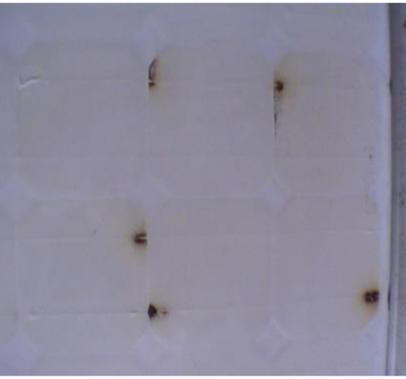
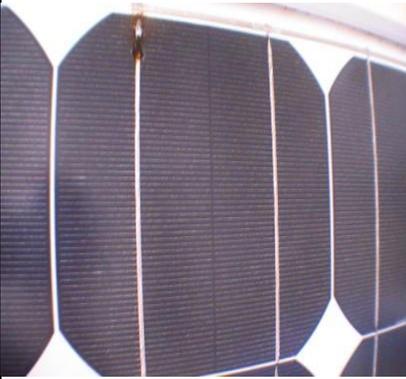
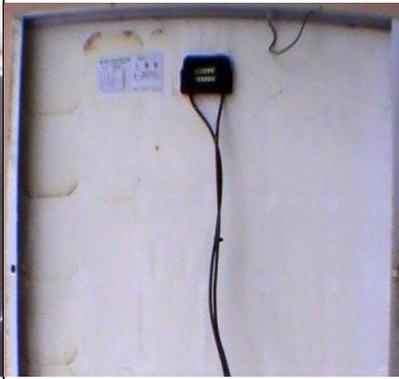
<p>Examples 4-6</p>

<p>Front and back side view of burn marks caused by open-circuited bypass diodes and current mismatch conditions (due to shading or cracked cells) [Köntges14].</p>		<p>Burn marks caused by defect bypass diodes or an interconnect failure in the junction box [Köntges14].</p>
<p>Severity</p>

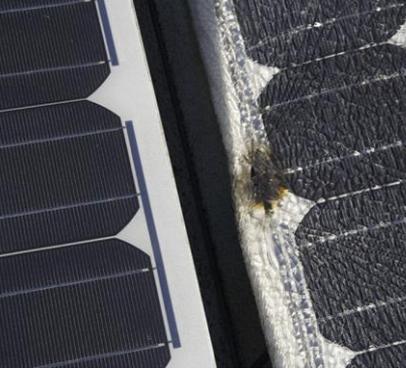
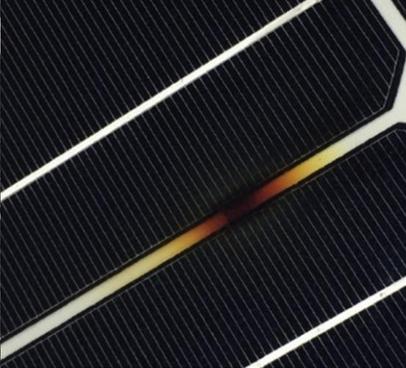
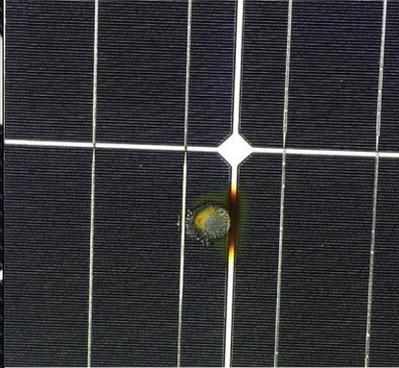
<p>Examples 7-9</p>

<p>Burn mark with broken glass caused by poor bussing ribbon soldering [Yang19]. (see also PVFS 1-8 and PVFS 1-8)</p>	<p>Burn mark due to intrinsic shunting caused by error in manufacturing process [Yang19].</p>	<p>Burn mark due to intrinsic shunting caused by error in manufacturing process [Yang19].</p>

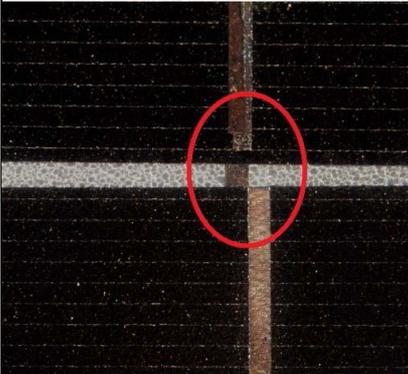
Dislocation of interconnection ribbon [Sinclair17].

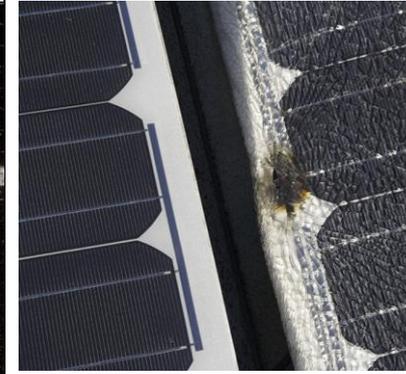
Poor soldering of string interconnect leading to burn mark and broken glass [Yang19]. (see also PVFS 1-7 and PVFS 1-8)

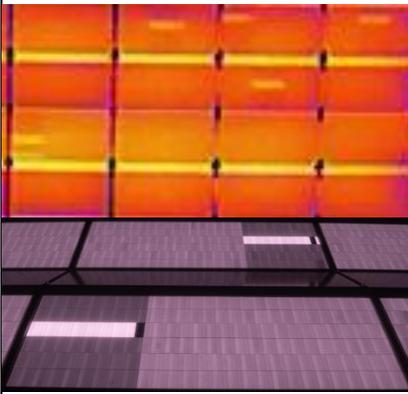
IRT and EL image of short circuited shingled cells due to incorrectly applied conductive adhesive [By the courtesy of Remy Wedig, pvControl].

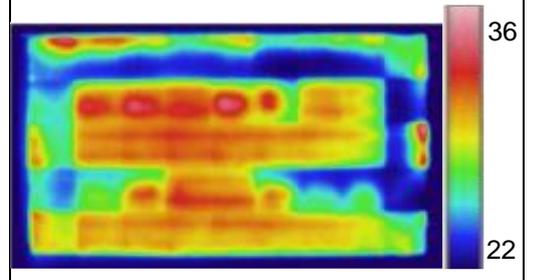
Dark IR thermography at Isc for a module affected by PID-s [Köntges14].

Mitigation	Corrective actions	Preventive actions (recommended)	Preventive actions (optional)
	Recovery of early-stage PID is possible by placing modules in non-sensitive polarity strings, applying a reverse voltage. More advanced PID cannot be fully recovered.	Modules successfully tested per IEC 62804-1 are less prone to PID. Optional for PID-resistant modules.	Placing the modules in non-PID-sensitive DC voltage strings with one terminal grounded using an inverter with a transformer or inverters with anti-PID features.

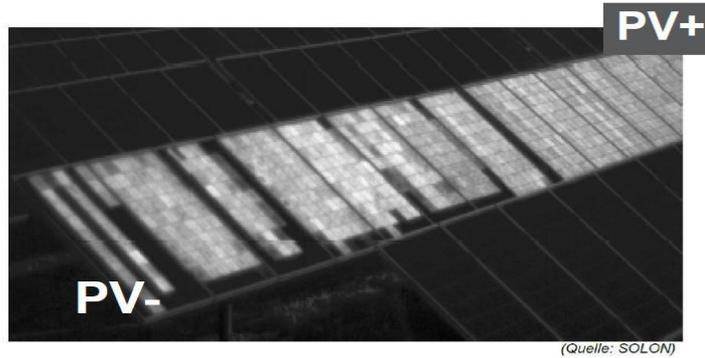
Strings with PID-s, detected with EL imaging [Köntges14].

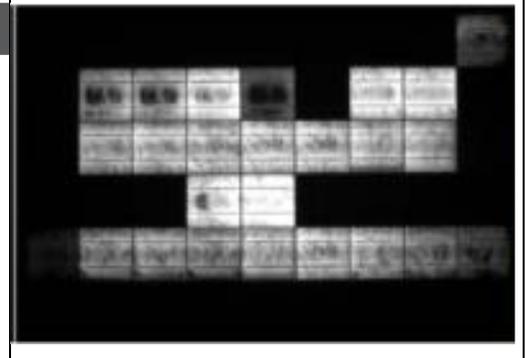
Electroluminescence image made at Isc for a module affected by PID-s [Köntges14].

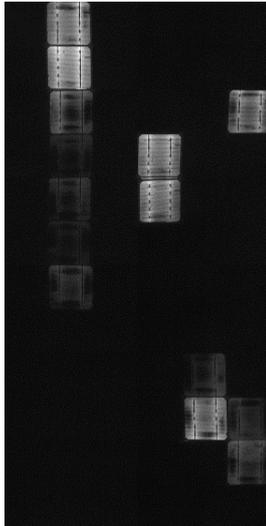
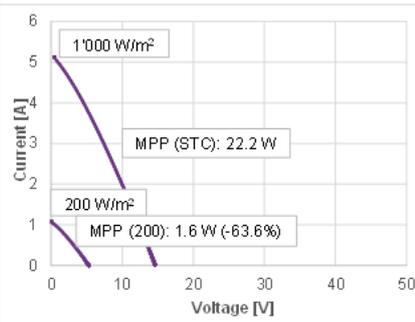
PID-s affected module with power loss of 89%, left: EL at 1.5 x Isc, right: I-V curve of the same module at 1000 and 200 W/m² [Herrmann21].

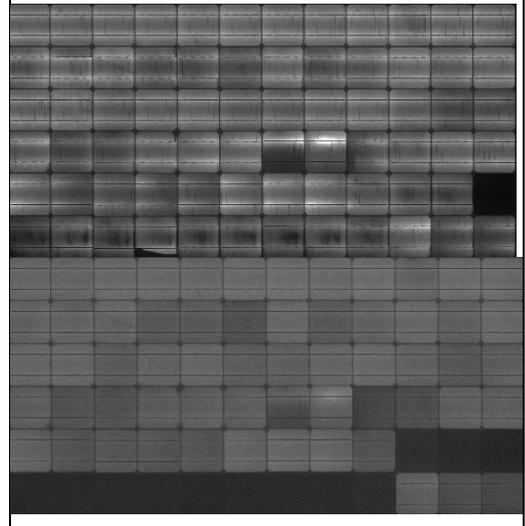
PID-s affected module with power loss of 14%. top: EL at 1.5 x Isc. bottom: EL of the same module at 0.2 x Isc [Herrmann21].

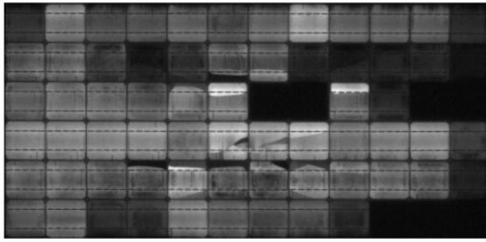
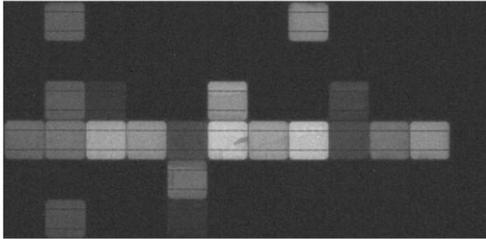
PID-s affected AI BSF module EL imaged at  $I_{sc}$  and  $0.1 I_{sc}$  shows chessboard pattern degradation, more visible at the lower bias current. STC IV curve shows decreased shunt resistance, FF and  $V_{oc}$  [Mahmood2024].

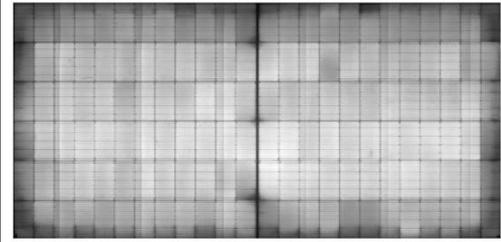
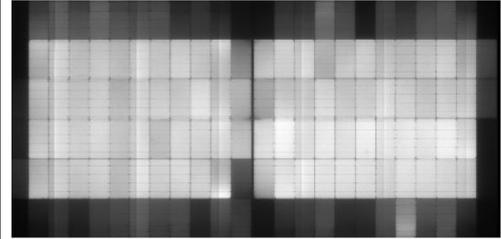
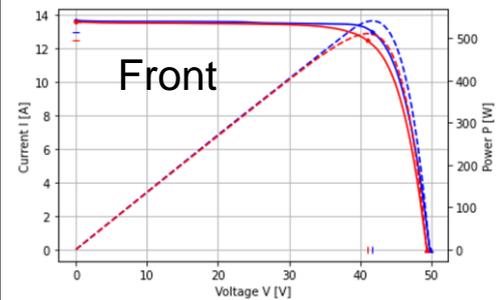
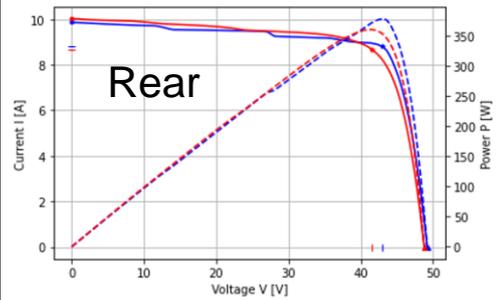
PID-s affected PERC p-type bifacial module EL imaged at  $I_{sc}$  and  $0.1 I_{sc}$  shows degradation near frame, more visible at the lower bias current. STC IV curves of front and rear show decreased FF [Mahmood2024].

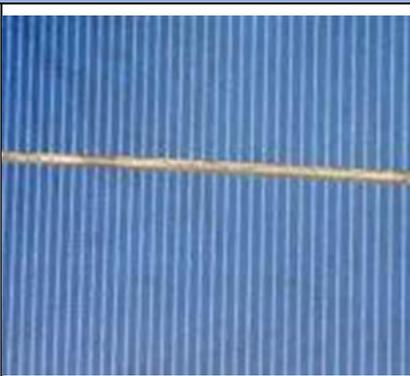
<p>Discolouration due to corrosion or to light-sensitive flux residues on the ribbon.</p>	<p>Discolouration due to corrosion on the ribbon [By the courtesy of SUPSI PVLab].</p>	<p>String interconnect corrosion. [Köntges17]</p>			
<p>Severity</p>

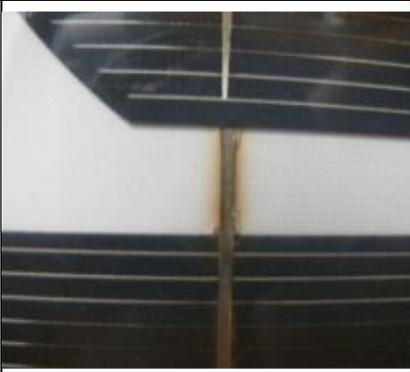
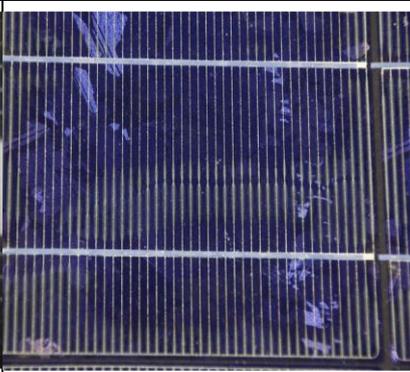
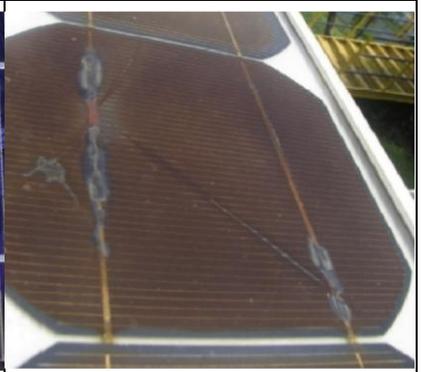
<p>Cell interconnect corrosion [Köntges17].</p>	<p>Modules with light Ag finger oxidation after 5 years in the field [Yang19].</p>	<p>Severe oxidation/corrosion and burn marks on the Ag fingers, busbars, and interconnects of modules after 25 years [Yang19].</p>			
<p>Severity</p>

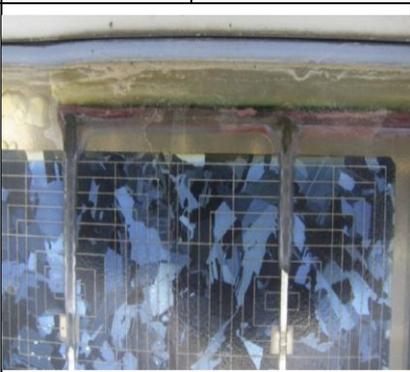
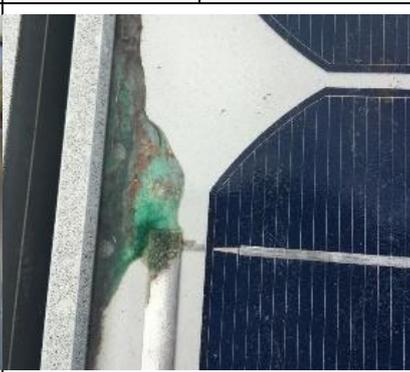
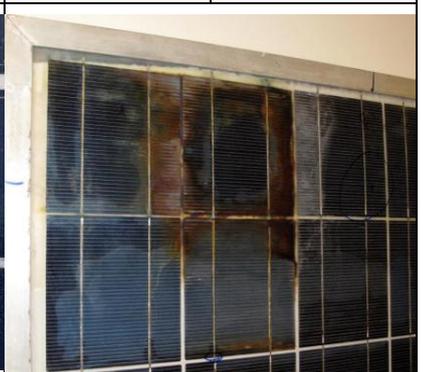
<p>Corrosion seen as red, green and black discoloration in the string interconnect [Yang19].</p>	<p>Busbar corrosion and delamination at the edge [By the courtesy of SUPSI PVLab].</p>	<p>Glass/glass module showing delamination and subsequent corrosion [Köntges17].</p>

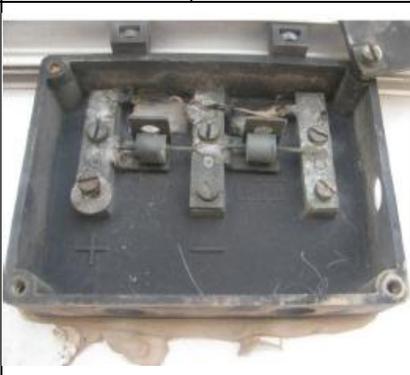
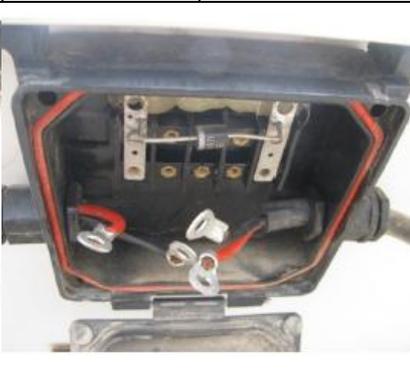
<p>Left: Missing junction box lid sealing with corrosion of contacts. Right: Good junction box sealing [India13].</p>		<p>Missing seal or strain relive of module cables, improper cable inlet [Sinclair17].</p>
<p>Severity</p>

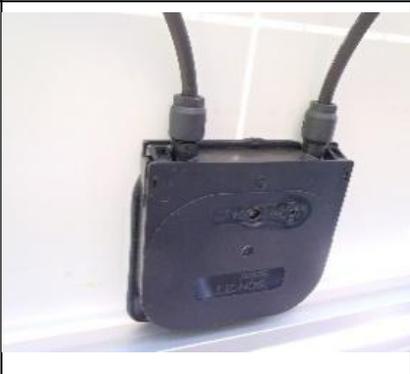
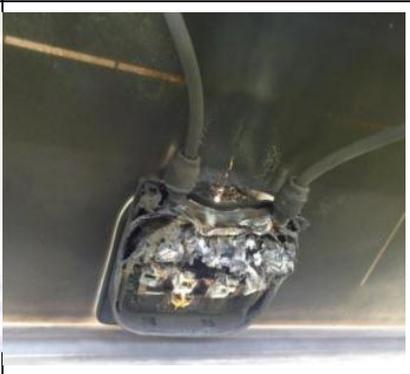
<p>Melted junction box [By the courtesy of TUV Rheinland].</p>	<p>Burned junction box caused by corroded contacts within the junction box [By the courtesy of TUV Rheinland].</p>	
<p>Severity</p>

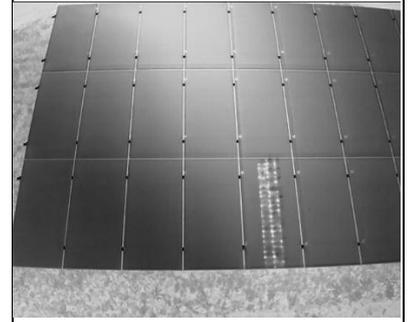
Example 10

A cold solder joint after the diode in any junction box (either outer or inner) [Köntges25] can result in a safety failure that is undetectable by IRT. The not connected bypass diode is visible with night EL inspection while applying string wise reverse voltage with 3%-5% of rated  $I_{sc}$  [by courtesy of Ternus & Diehl GbR].

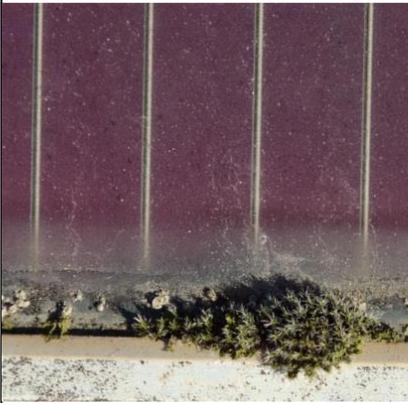
Moss growing on the edge of a module combined with edge soiling [Köntges17].

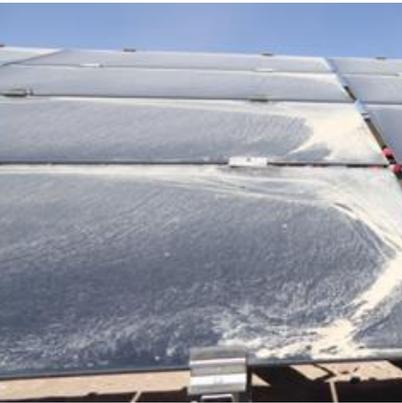
Soiling pattern on a system in the Atacama desert [By the courtesy of ISE FhG].

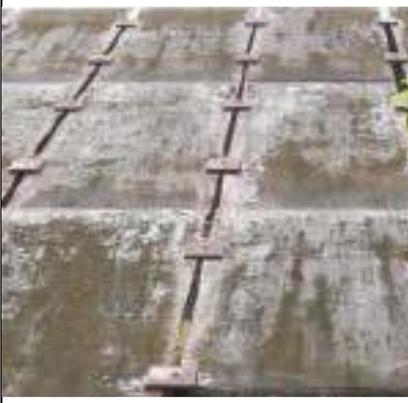
Examples 7

Heavy biofilm soiling [Köntges16].

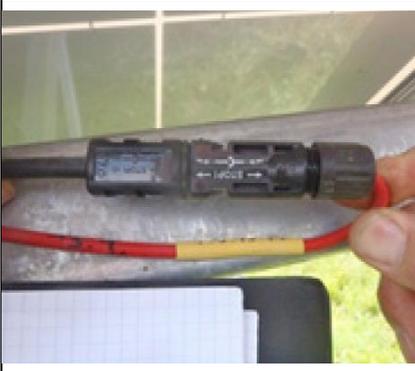
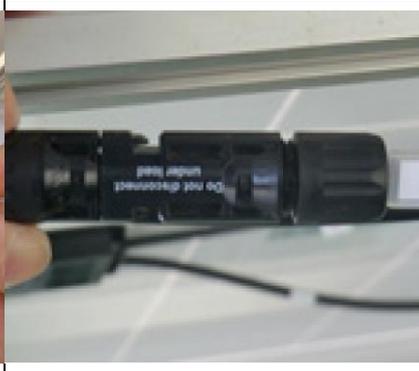
<p>Examples 1-2</p>

<p>Connectors (male of female) are of different brand or type and obviously do not match [Moser17].</p>	<p>Connectors (male of female) are of different brand or type and obviously do not match [Moser17]</p>				
<p>Severity</p>

Mitigation	Corrective actions	Preventive actions (recommended)	Preventive actions (optional)
	<b>All not matching connectors should be replaced.</b>	Ask supplier or check module/inverter spec sheets for the type/manufacturer of connector, only connectors from the same manufacturer and certified as compatible should be mated together.	Verify that both modules and inverters are delivered with the same connectors. Provision of spare connectors and string cables with connectors of the same type as the module connectors.

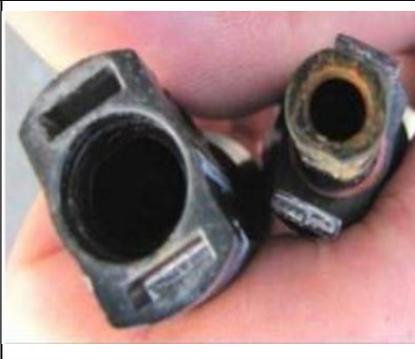
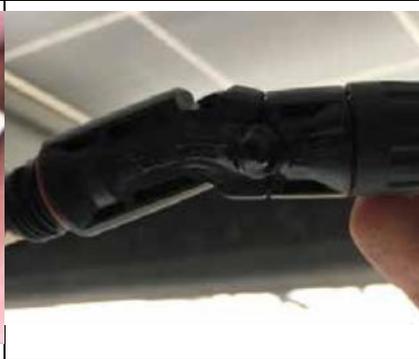
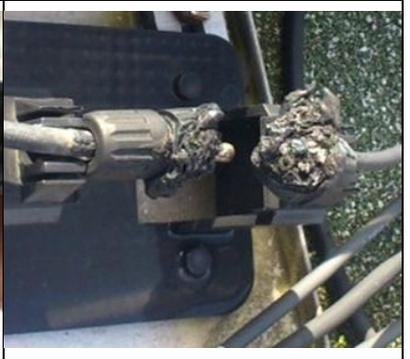
<p>Examples 3-5</p>

<p>Corroded connector due to cross-mating [By the courtesy of Stäubli].</p>	<p>Melted connector due to cross-mating [By the courtesy of Stäubli].</p>	<p>Burned connector due to cross-mating [By the courtesy of Stäubli].</p>			
<p>Severity</p>

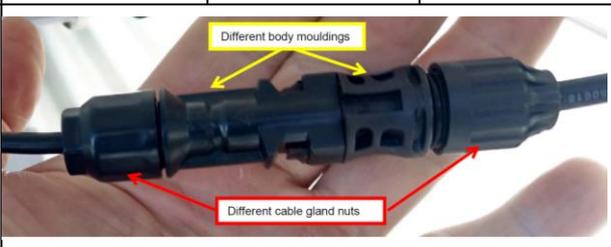
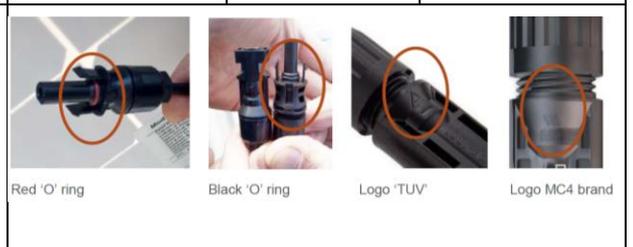
<p>Examples 6-7</p>

<p>Different types of connectors recognisable by different body mouldings and cable gland nuts [ESV guide].</p>	<p>Different types of connectors recognisable by different 'O' rings or logos [ESV guide].</p>				
<p>Severity</p>

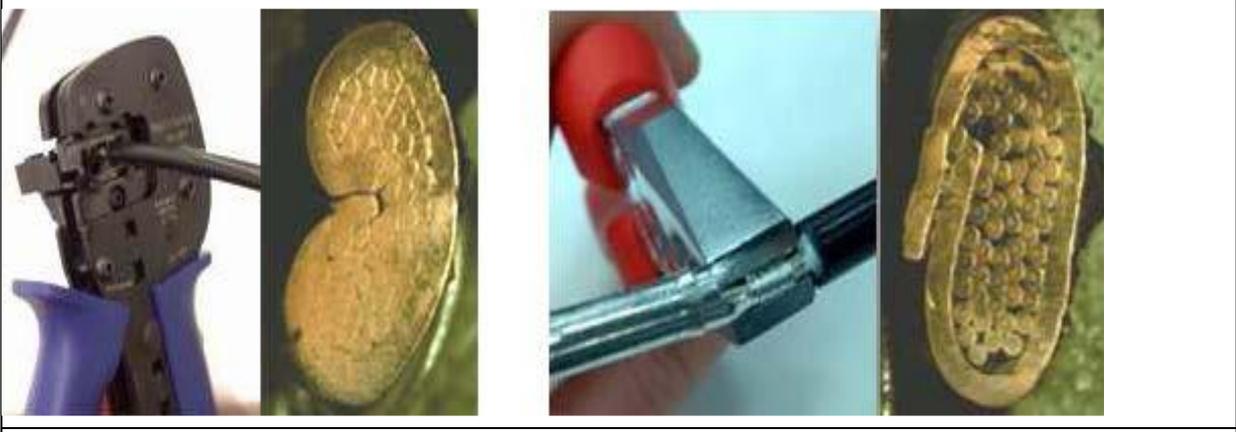
<p>Examples 7</p>

<p>Incorrect crimping (right) versus correct crimping (left) [PVSurvey19].</p>					
<p>Severity</p>

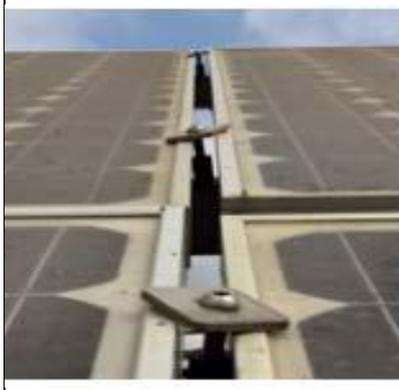
Wrong combination of clamps and modules [Moser17].

Safety:		Performance:		
Mitigation	Corrective actions	Preventive actions (recommended)		Preventive actions (optional)	
	<b>Modules with a safety risk or a severity of 5 should be replaced.</b>	Use only compatible clamps (mounting structure/ modules/ clamps) and follow manufacturer mounting instructions. Check local wind and snow loads.		Testing of non-standard mounting configurations by an accredited test laboratory (eg. facade mounting), perform regular system inspections

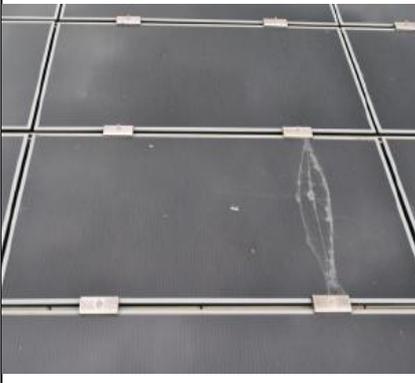
Examples 4

Glass breakage caused by poor clamp design [Moser17]. (see also PVFS 1-8)

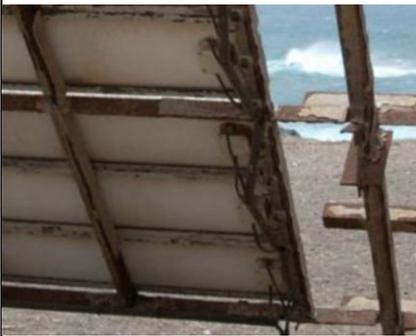
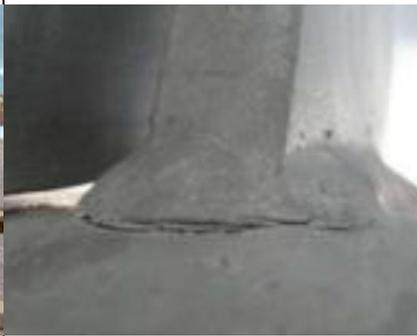
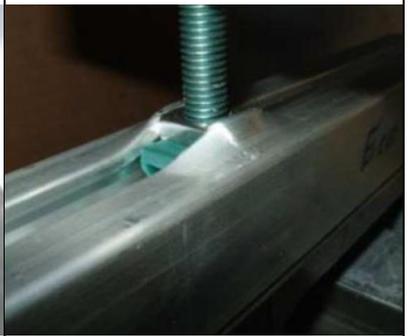
<p>Examples 1-3</p>

<p>Corrosion due to salt water [Köntges16].</p>	<p>Cracks in mounting structure due to mechanical stress [Köntges16].</p>	<p>Screw canal bends due to mechanical stress [Köntges16].</p>
<p>Severity</p>

Mitigation	Corrective actions	Preventive actions (recommended)	Preventive actions (optional)
	<b>Mounting structures with a direct safety risk should be replaced or repaired.</b>	Use only compatible mounting structures (ground/mounting structure/modules) and follow manufacturer mounting instructions. Check local load (conditions (wind, snow, other).	Regular system inspections. Testing of non-standard mounting configurations by an accredited test laboratory (e.g. facade mounting), perform regular system inspections.

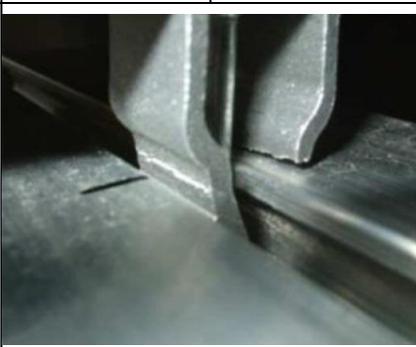
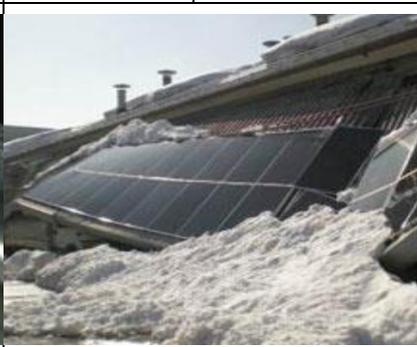
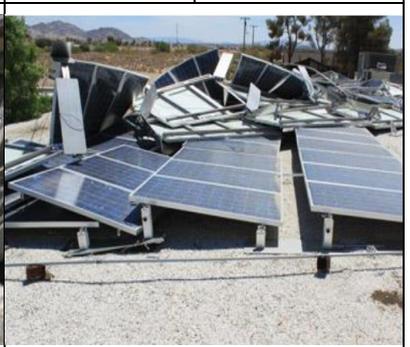
<p>Examples 4-6</p>

<p>Bracket fractured due to mechanical stress [Köntges16].</p>	<p>Undersized mounting structure for local snow load conditions [Köntges16].</p>	<p>Undersized mounting structure for local wind conditions [India13].</p>
<p>Severity</p>

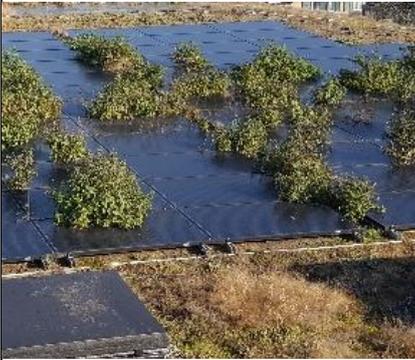
Missing maintenance on flat green roof [By courtesy of SUPSI PVLab].

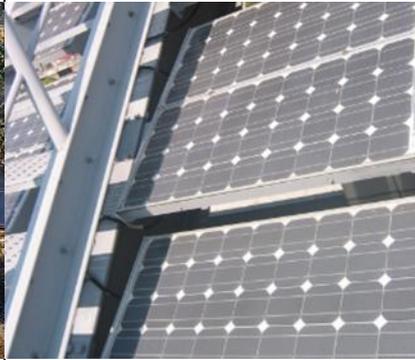
Vertical shading of a standard module with 3 bypass diodes [By courtesy of J.Lin PV Guider].

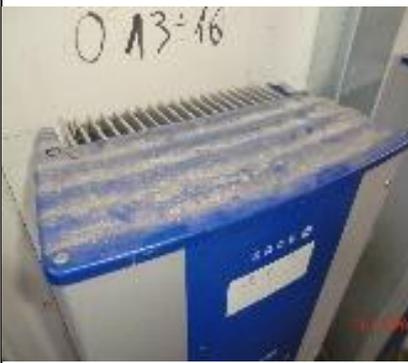
Dust blocking heat dissipation [By courtesy of TUV Rheinland].

Action	Corrective actions	Preventive actions (recommended)	Preventive actions (optional)	
	Once identified the origin of the temperature derating the failure should be repaired. The filters and in general heat dissipation path should be cleared of obstruction.	Follow the given installation procedure, use of adequate cooling technology, perform regular inspections of the ventilation units.	Monitoring of inverter temperature

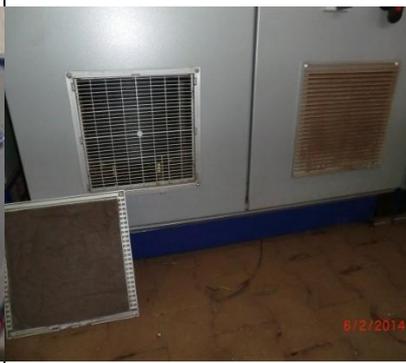
A soiled air filter causes over-heating [By courtesy of TUV Rheinland].

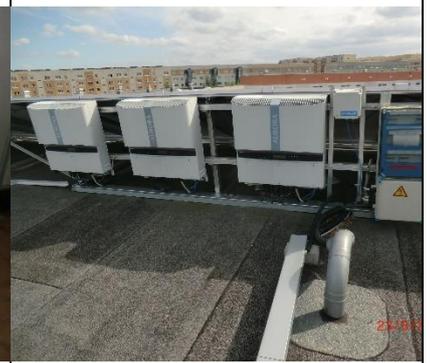
Installation not appropriate (direct exposition to sun) [By courtesy of TUV Rheinland].

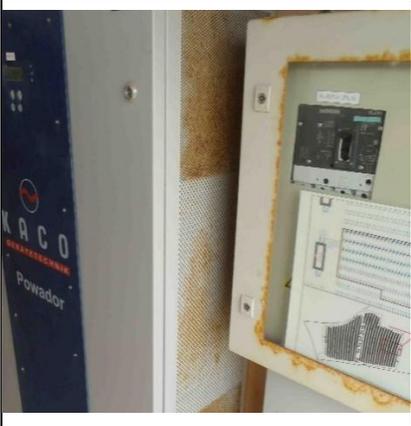
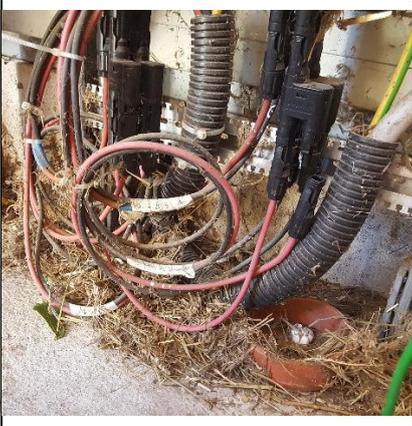
<p>Examples 4-5</p>

Component	Inverter			PVFS 4-2vs.01
Defect	Incorrect installation			
Appearance	The inverter must be installed according to the installation instruction. A common failures is the installation near flammable, explosive, corrosive or humid sources. Also the minimum distances to bottom, top or to the sides are not always fulfilled. If the input cables are not fixed properly, increased temperatures can occur at the loose contact point which lead to lower performance or risk of fire. Inverters must always be accessible for operation and maintenance and properly secured to an appropriate base.			
Detection	VI (MON)			
Origin	Violating instruction manual, e.g. installed nearby flammable materials as wood or in direct sun light. Minimum distance to adjacent components not maintained.			
	Production <input type="checkbox"/>	Installation <input checked="" type="checkbox"/>	Operation <input type="checkbox"/>

Impact	Incorrect installation of the inverter can cause danger to users and hazardous conditions and can result in <b>overheating</b> of the inverter. The use of the inverter in the presence of flammable vapours or gases can lead to explosions. The inverter housing can become very hot under operation. Follow the instruction to provide gaps from both sides and top for adequate cooling. Direct sunlight on the inverters must be avoided. The inverter must be safely accessible to avoid accidents during maintenance work.			
	Safety:

Action	Corrective actions	Preventive actions (recommended)	Preventive actions (optional)	
	Dismount the component and follow the installation procedure.	Follow the given installation procedure, use of adequate cooling technology, perform regular inspections of the ventilation units.	Monitoring of inverter temperature.

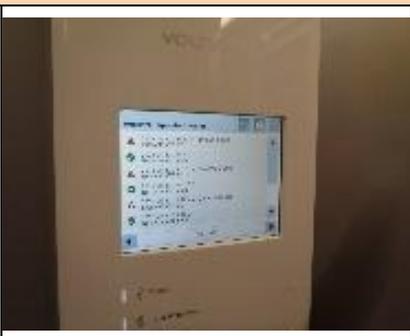
Component	Inverter		PVFS 4-3vs.01
Defect	Not operating (complete failure)		
Appearance	If the inverter does not work despite good production conditions, common problems are the lack of restart after grid faults or <b>isolation faults</b> . The inverter may show fault codes to help understanding the problem. This can be observed by checking the display or the data log of the monitoring system. Examples for hardware defects in the inverter are discoloured or burned cable interconnections or fuses. Damaged parts can be found by visual inspection or infrared thermography (IRT).		
Detection	MON, (VI, I-V, VOC)		
Origin	A complete failure of the inverter occurs due one or more malfunctions of single hardware or software component of the inverter or faults due to grounding issues, e.g. high humidity inside the inverter, or a firmware issue.		
	Production <input type="checkbox"/>	Installation <input type="checkbox"/>	Operation <input type="checkbox"/>

Impact	The complete failure of the inverter leads to significant performance losses and immediate actions must be taken. When the restart does not work or the fault occurs recurrently the origin must be identified in most cases by a service team. Software issues can be solved by updating the firmware for technical reasons or to update the system to new standards/grid technical requirements. While damaged hardware components of central inverters are usually repaired, string inverter are replaced more often for economic reasons. Damaged hardware can cause fire and electric shock hazards and must be repaired by qualified personnel.		
	Safety:

<p>Insulation failure [TUV Rheinland]</p>	<p>Not operating inverter [TUV Rheinland].</p>	<p>Damaged hardware component [Sinclair17].</p>			
<p>Severity</p>

Action	Corrective actions	Preventive actions (recommended)	Preventive actions (optional)
	Restart the inverter. Replace the components with defect or abnormal temperature. Update the software.	Use IRT and VOC to check the components and connection to find poor connection or defect components.
