EXPERIENCES AND ANALYSIS OF DEFECTS IN PV MODULES UNDER OPERATION

Fraunhofer Center for Silicon Photovoltaics CSP

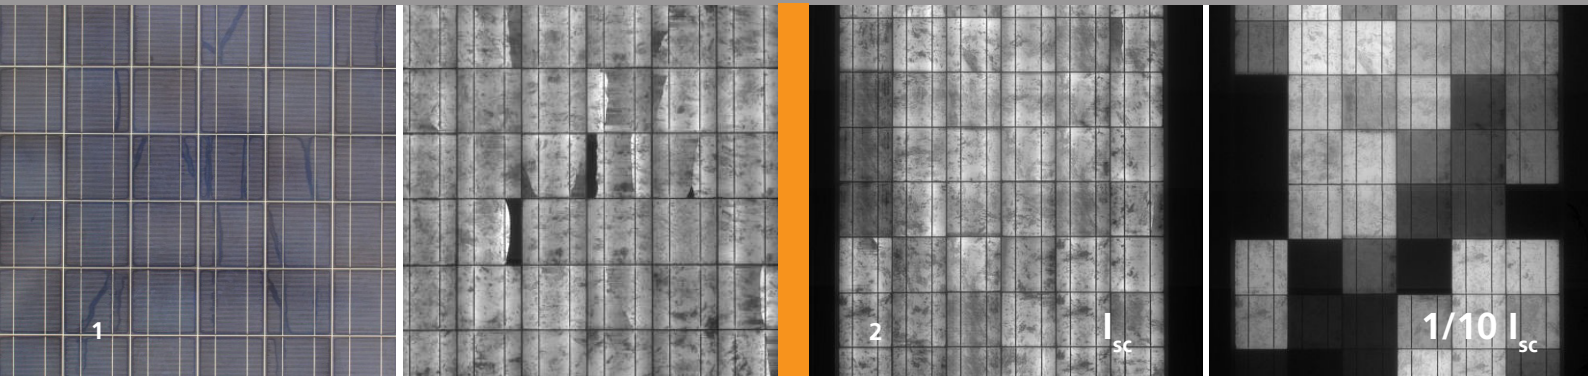
- 1 Discoloration »snail trails« and corresponding crack in solar cells.
- 2 Detection of PID by means of electroluminescence with different levels of current.

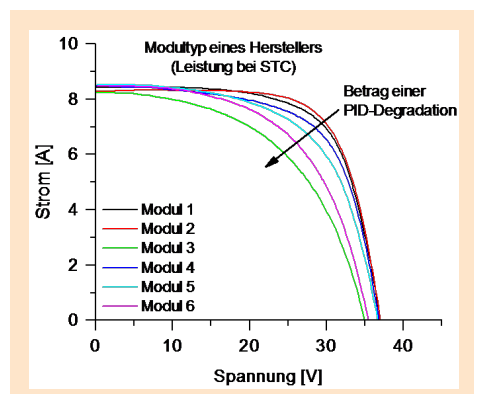
4 IV curves for modules with different grades of PID.
